MSC-02680

APOLLO 13 MISSION REPORT

Mission Evaluation Team

September 1970

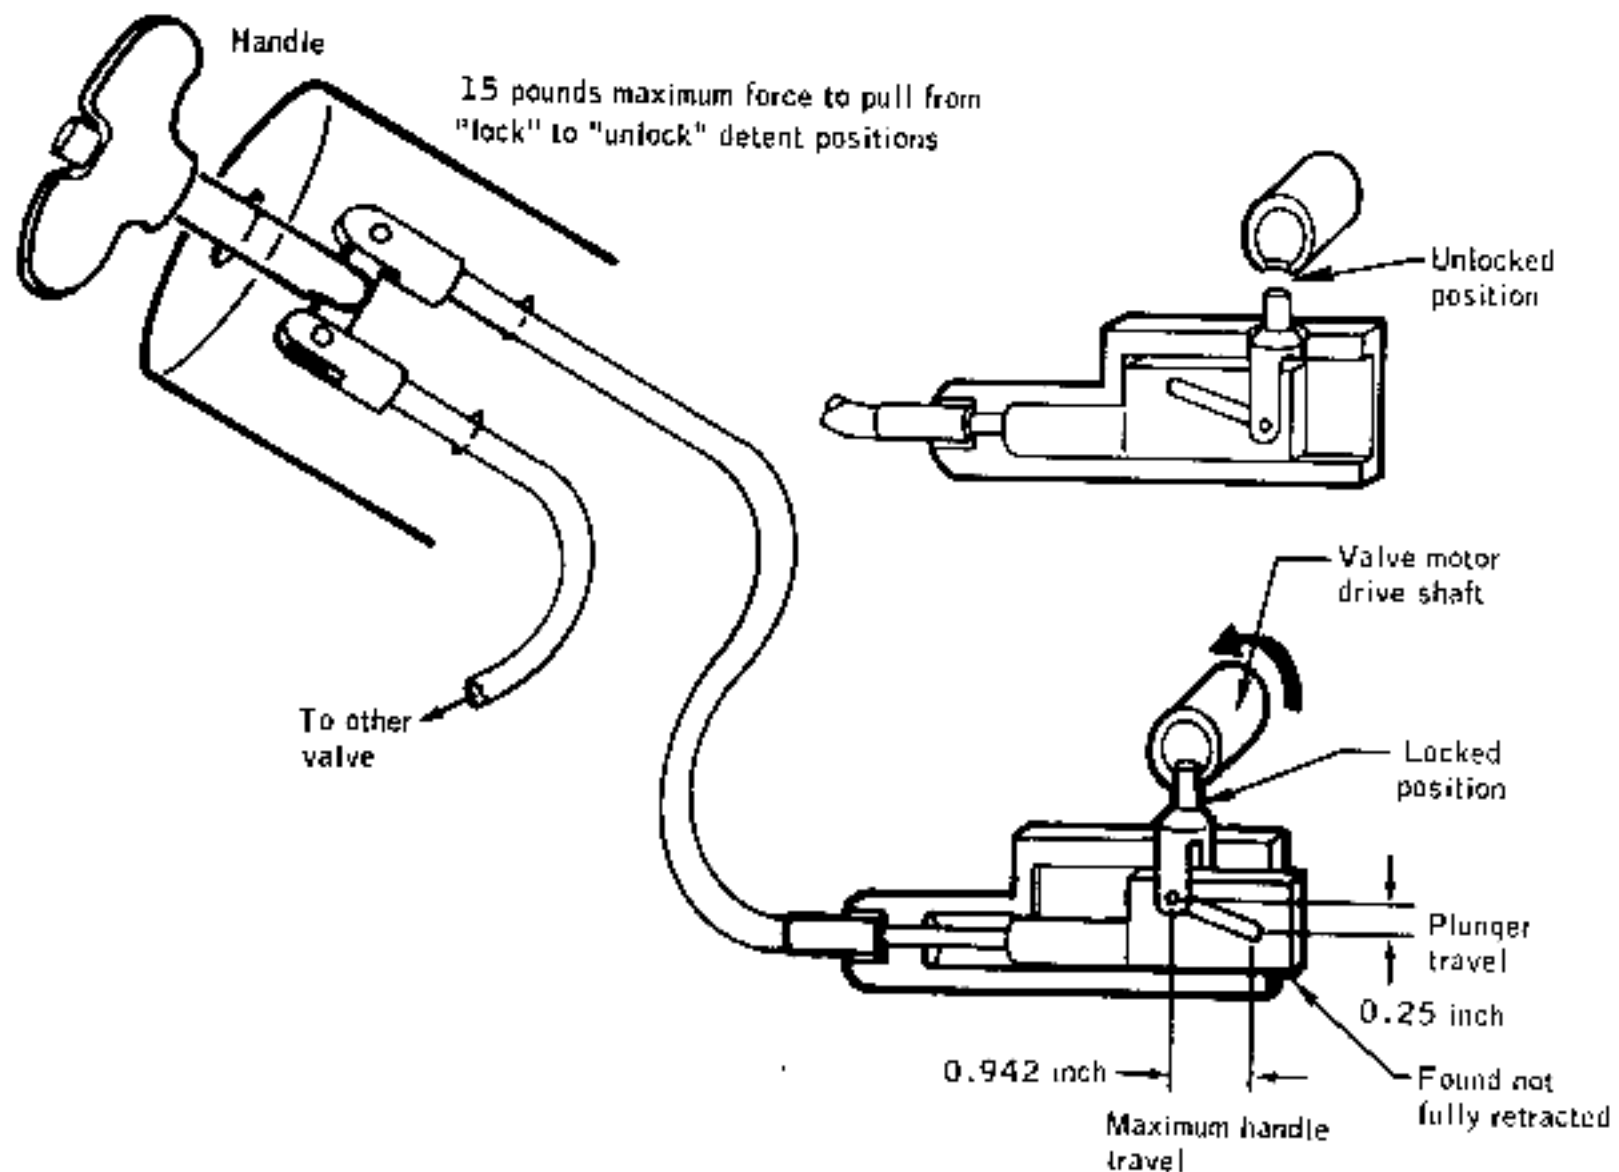
Figure 14-1.- Post-landing vent valve lock.

The valve-lock mechanism rigging tolerances were found to be within specifications. When reassembled in the spacecraft, the malfunction was duplicated with only partial travel of the handle.

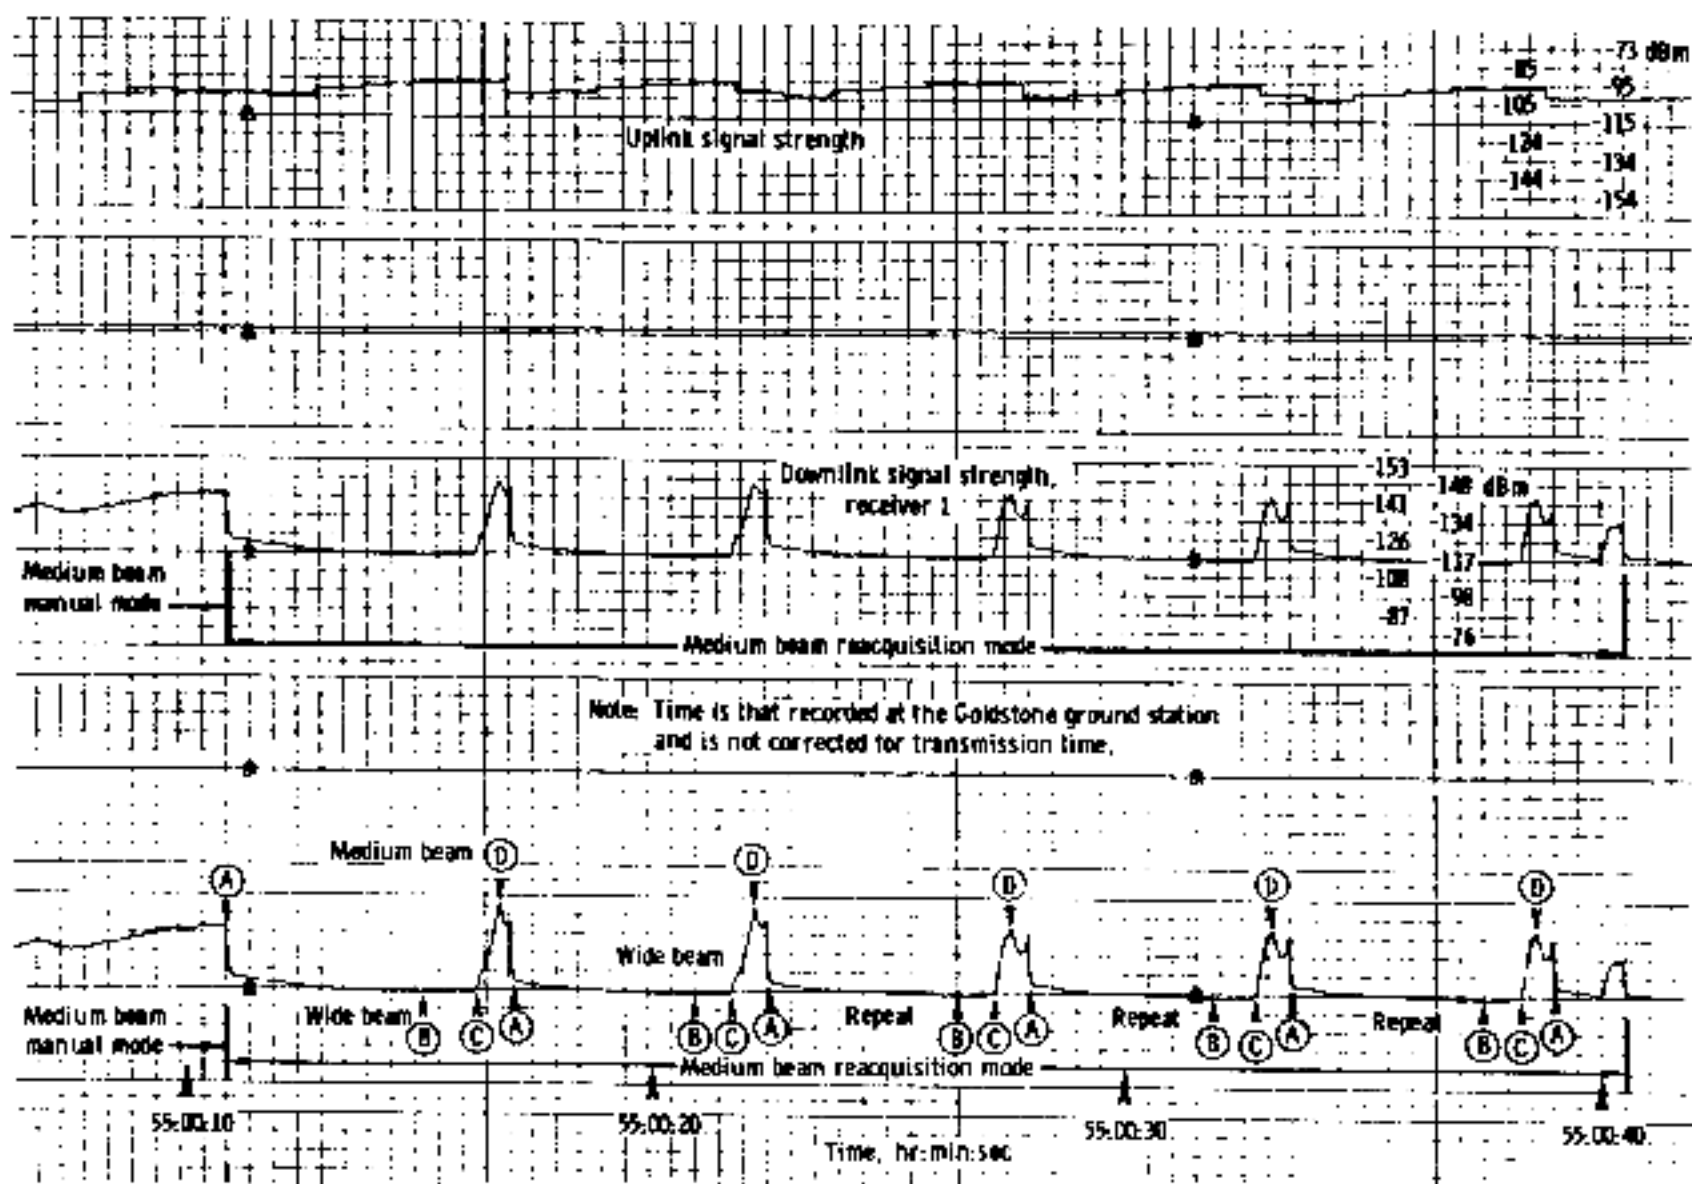
Figure 14-6.- Recorded signal strengths during high-gain antenna operation.

results of this test shifted the scan-limit functions but did not produce the necessary change in the scan-limit slope. Consequently, a failure in the electronic box is ruled out.

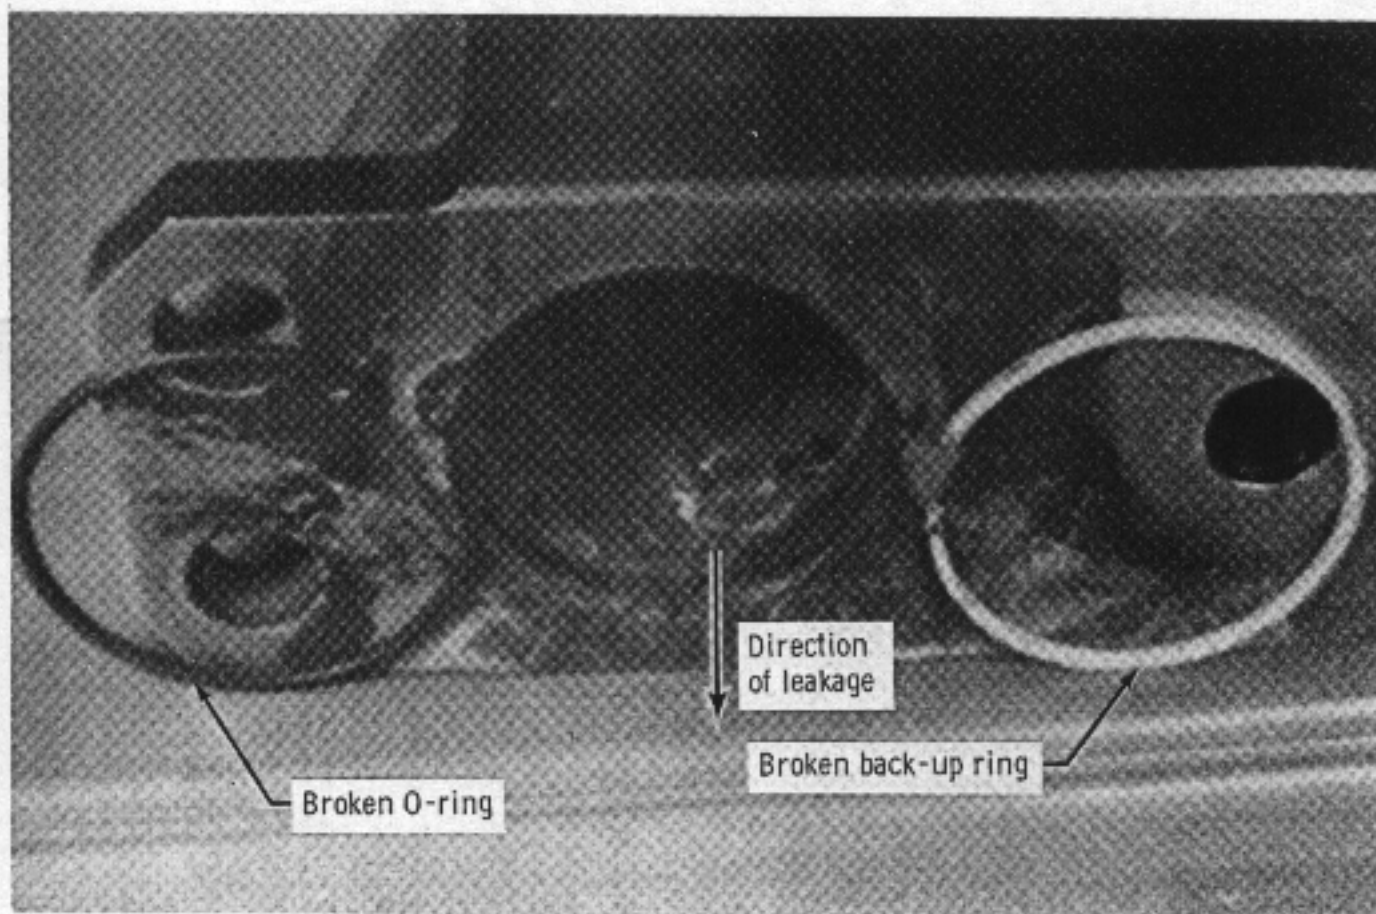
Figure 14-9.- Plenum side of breech-plenum interface.

sheet (fig. 14-10) will be applied to the interior of the breech plenum area on future spacecraft. The protection provided by the polyimide has been proof-tested by firing the assembly without the O-ring, simulating a worst-case condition.

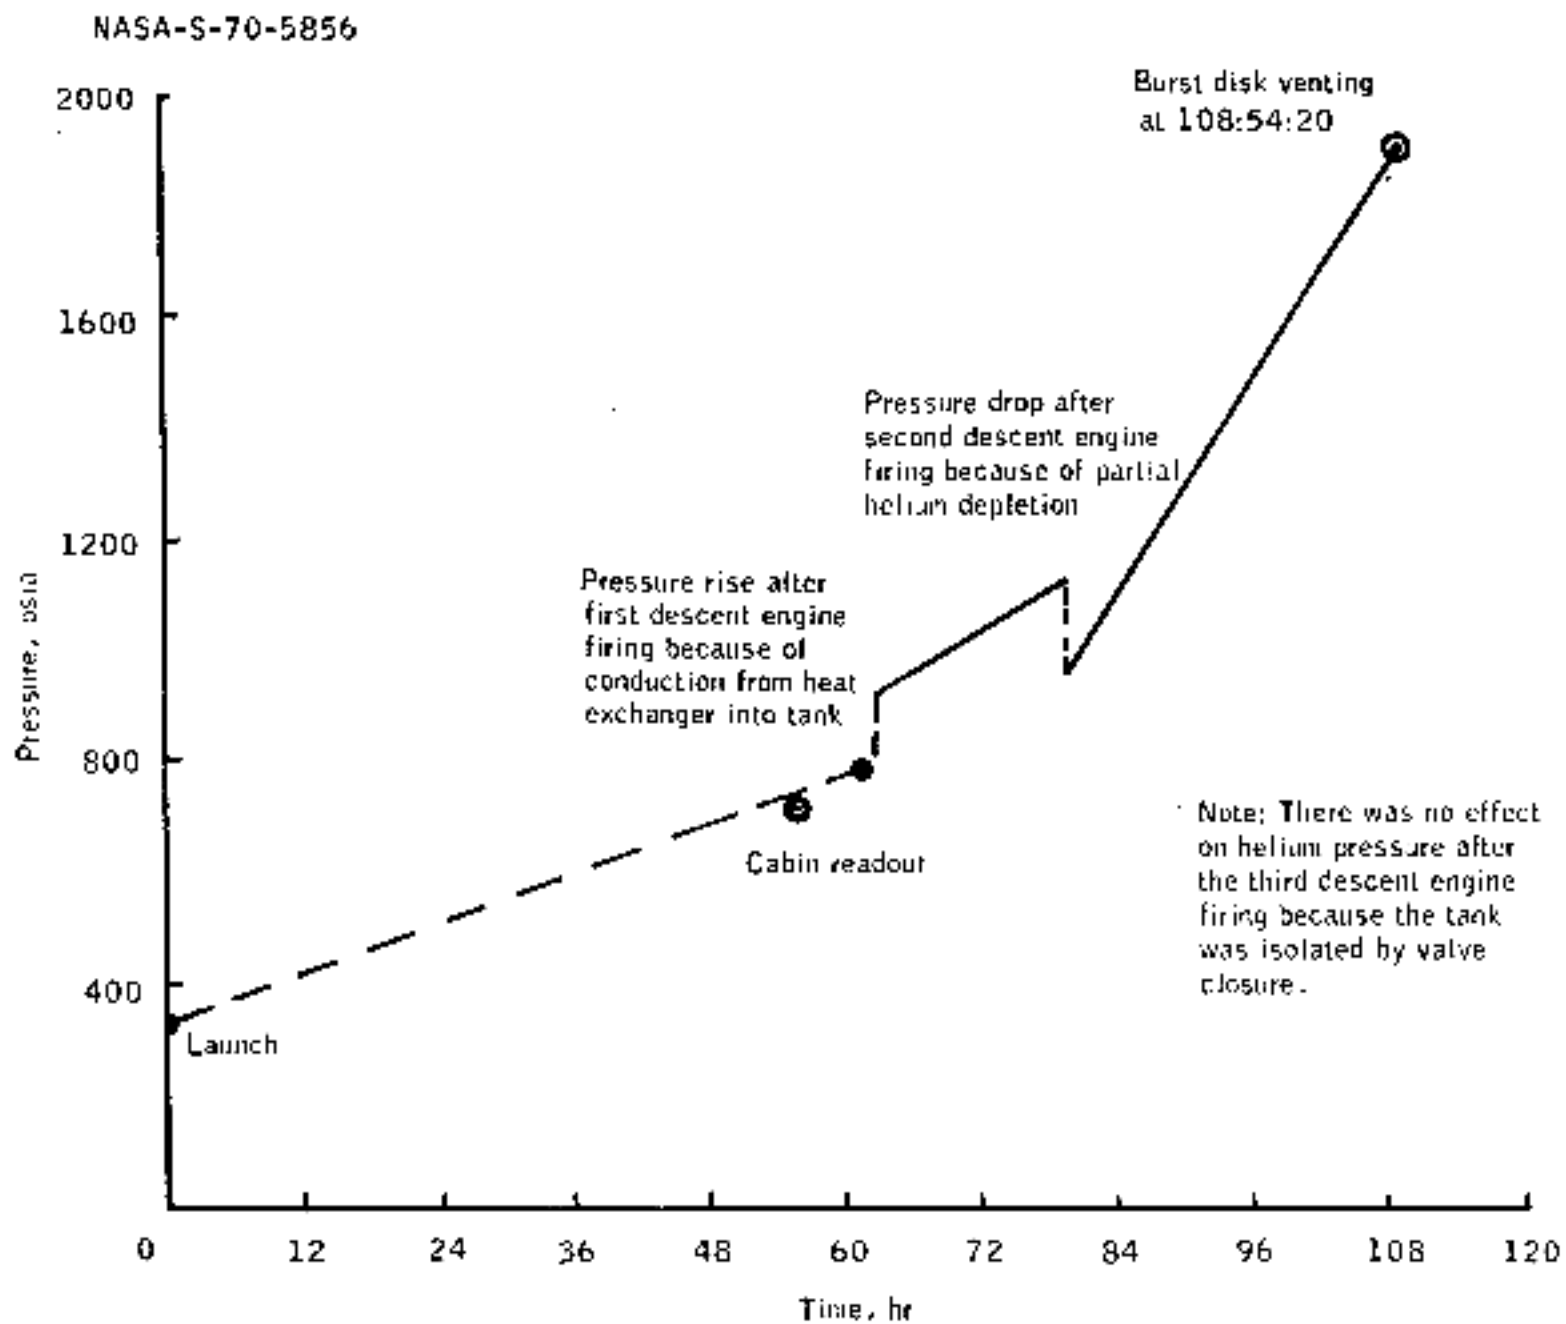
The most likely cause of the anomaly is a tank-insulation degradation which would result in increased heat conduction to the helium. The insulating characteristics of the annular vacuum in tank was most likely degraded by the introduction of a contaminant (probably hydrogen) in extremely small concentrations (approximately  $10^{-6}$  pounds). These contaminants when vaporized can exponentially increase the thermal conductivity in proportion to their vapor pressure, as indicated by special tests. While loading helium into the tank, the contaminants would freeze upon the inner shell. In the frozen state, the pressure of the contaminant is too low to significantly affect the thermal conductivity. However, the flow check which preceded the cold-soak operation would vaporize the contaminants in the vicinity of the heat exchanger lines which pass through the annulus. The subsequent increase in thermal conductivity could cause the abnormally high pressure-rise rate observed during the cold soak. These vapors would slowly condense on the cold ( $10^{\circ}$  R) inner wall, resulting in the pressure rise rate dropping to the nominal level, as was observed. The rise rate would remain normal until the helium temperature increased above the vaporization temperature of the contaminant.

Figure 14-14.- Inflight profile of supercritical helium tank pressure.

A screening test was devised for all future flight tanks to supplement normal helium tank testing. The purpose of this test is to determine the pressure rise rate for a wide range of helium temperatures from approximately  $9^{\circ}$  to  $123^{\circ}$  R. For a perfect tank, the steady-state rise rate should remain at approximately 8 psi/hour over the entire range of temperatures. The Apollo 14, 15, and 16 tanks have been subjected to the screening test, and each exhibit the same phenomena observed during Apollo 13, but to a lesser degree. For new tanks, the manufacturer will periodically analyze the gases removed from the vacuum jacket during pump down for possible contaminants. The pressure in the jacket will be measured 2 or 3 weeks after pumpdown to verify vacuum integrity.

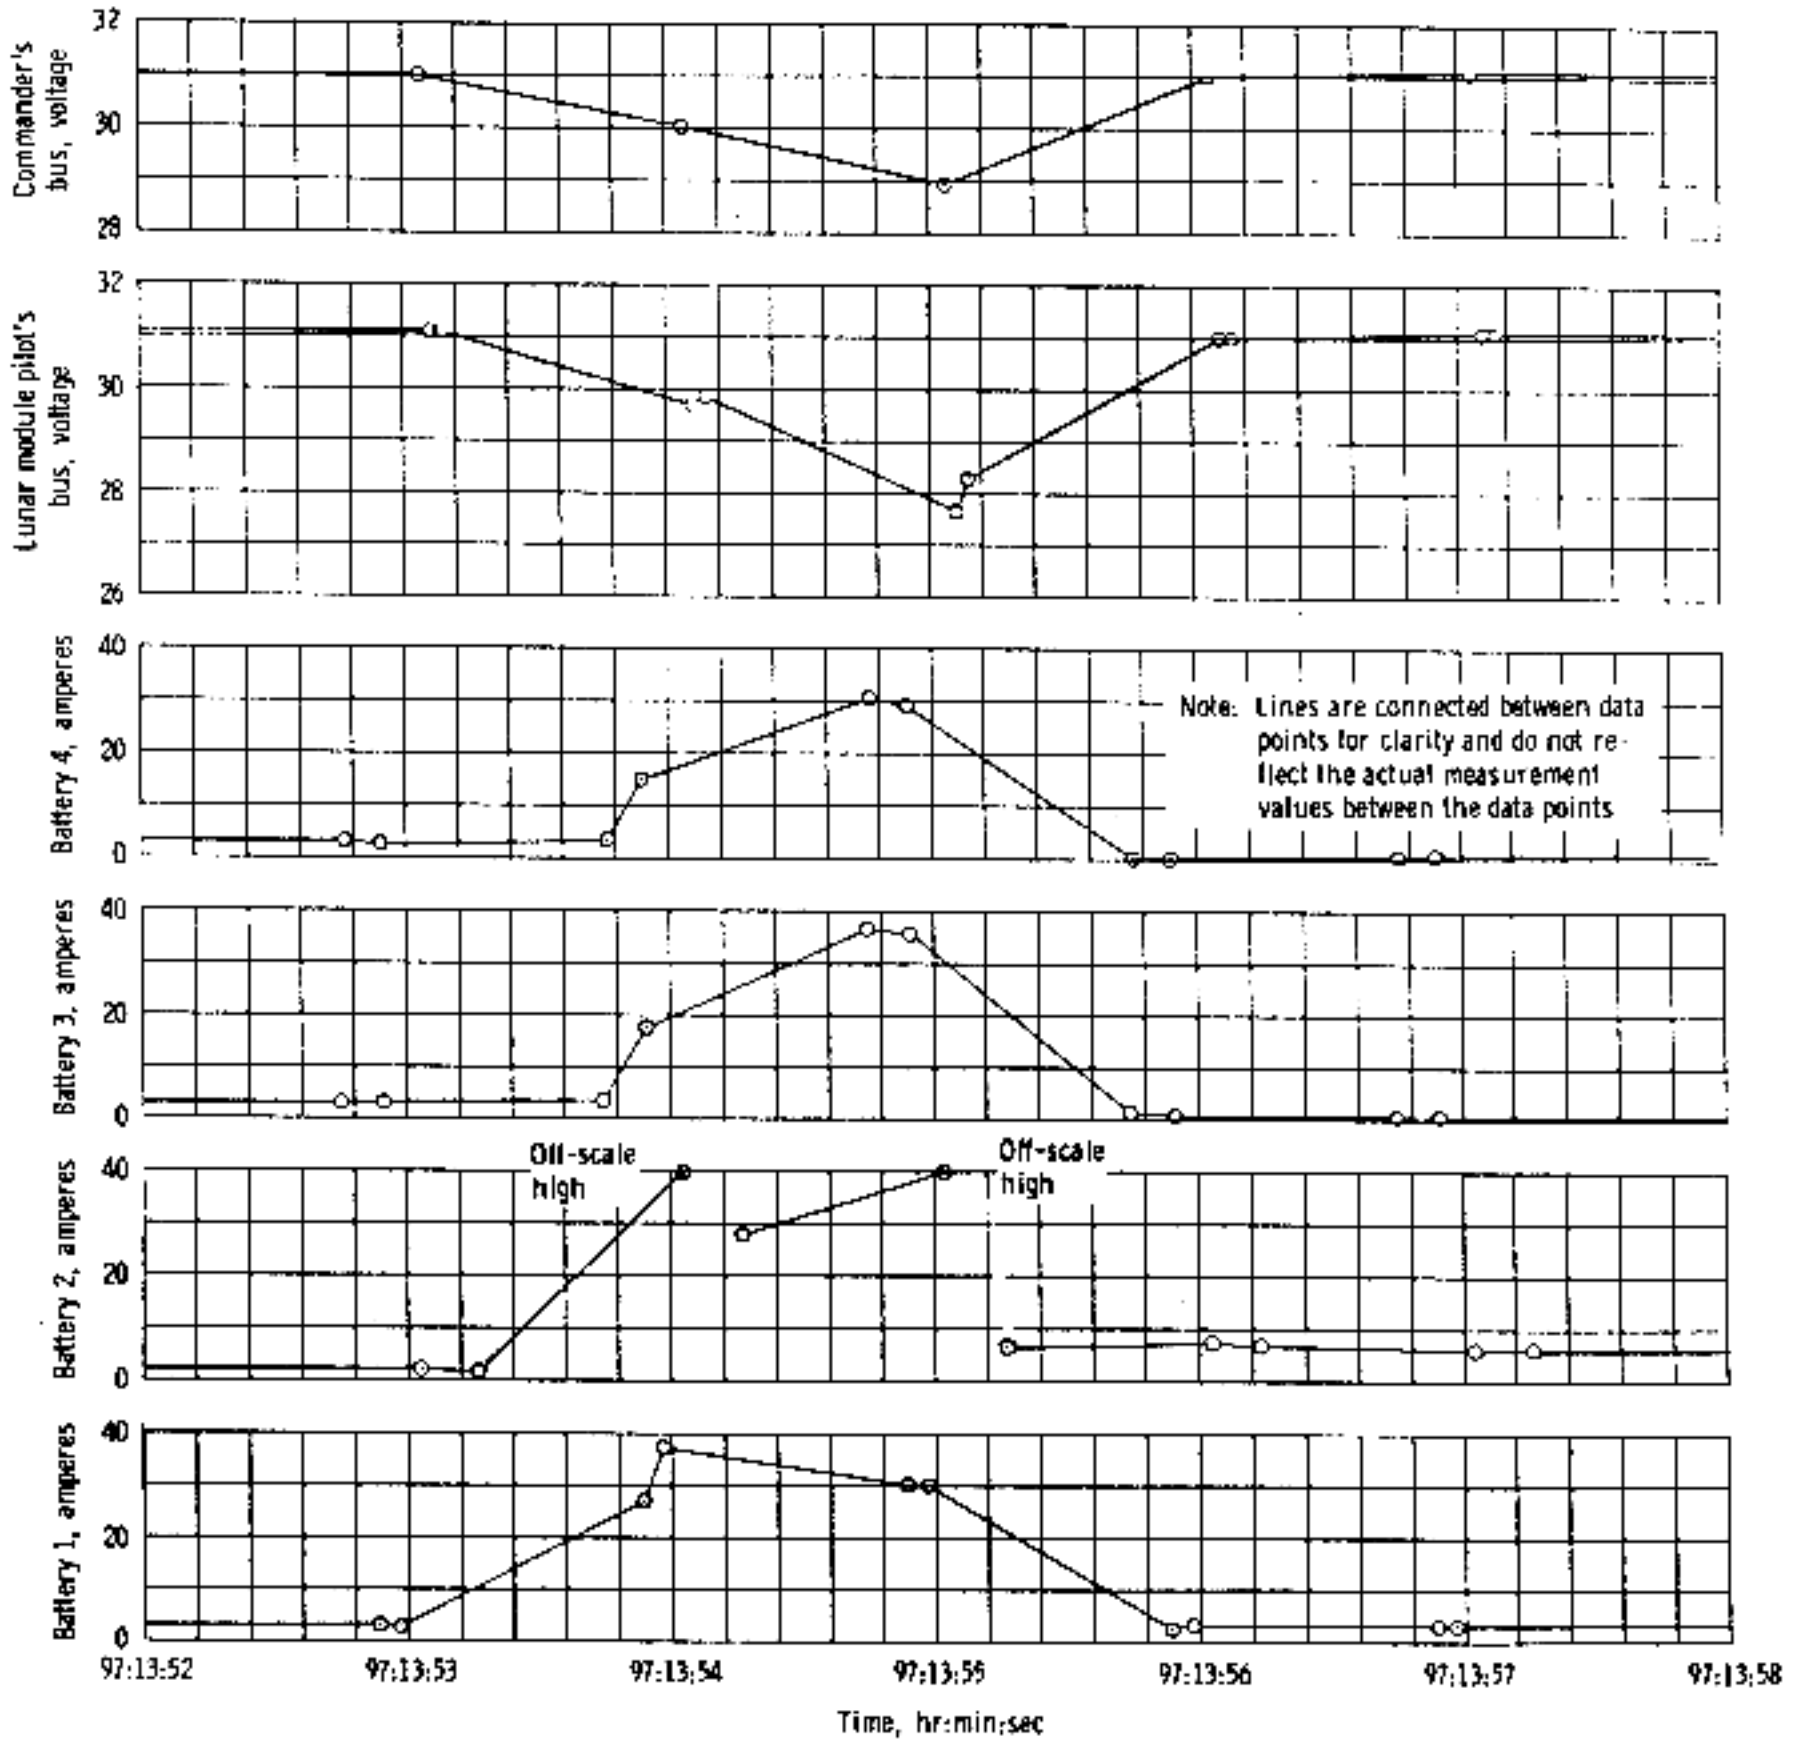
Figure 14-16.- Battery electrical transients.

The thumping noise occurred at about the same time as the current spikes. The current spikes show that a momentary short circuit existed in the Lunar-Module-Pilot side of the dc electrical system, which includes descent batteries 1 and 2 (fig. 14-16). The current surge was not of sufficient duration either to open the balance-load cross-tie circuit breakers, to display a reverse current indication, or to trip a battery-off relay as a result of an overcurrent condition.

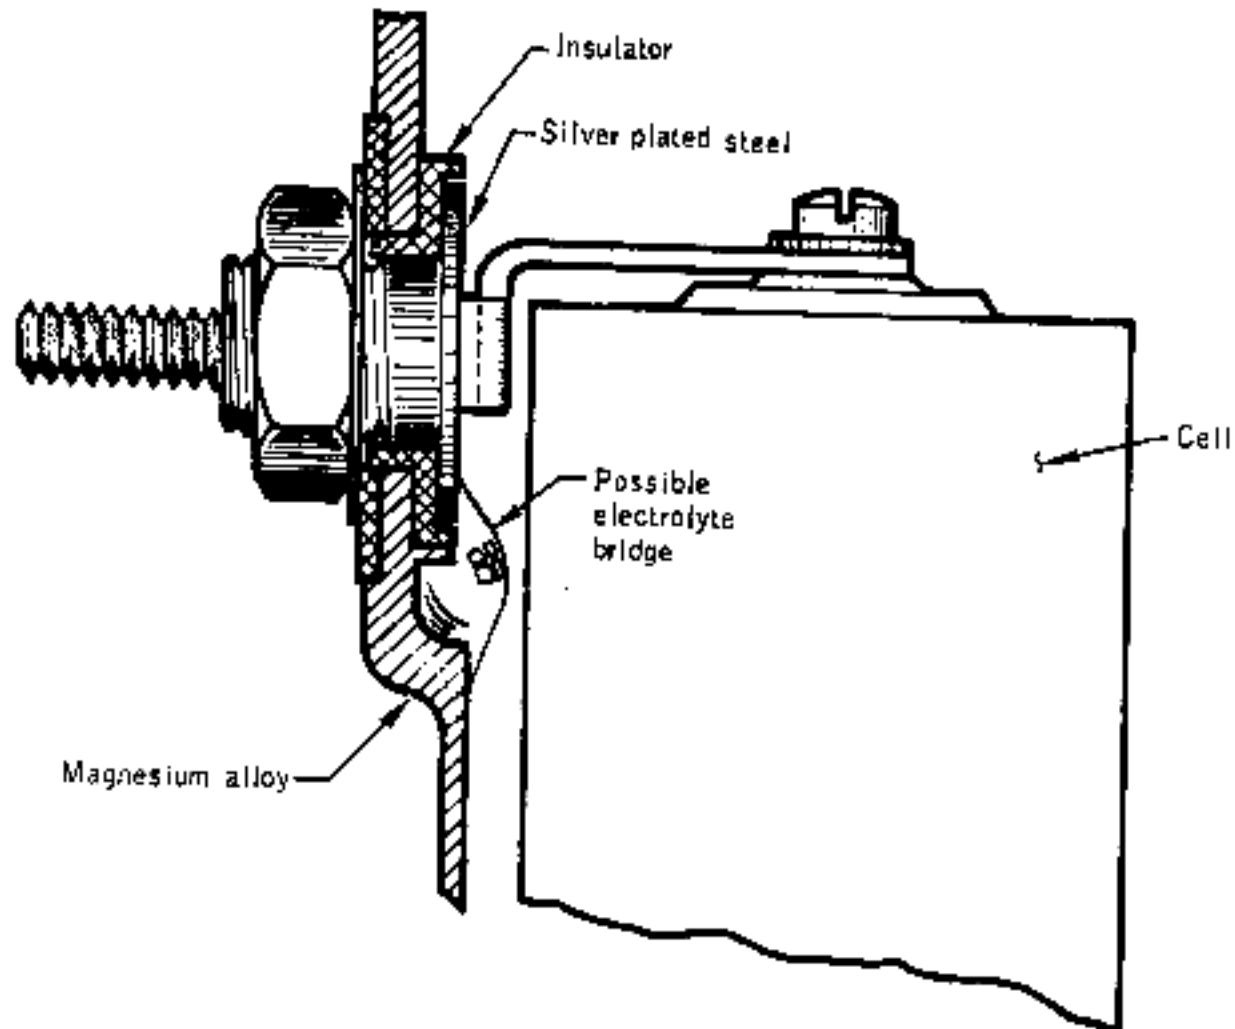
Figure 14-17.- Descent battery terminal configuration.

The battery potting will be improved to prevent electrolyte bridging between the battery terminals and case. These improvements include coating the inside of the battery case with epoxy paint before the battery is assembled and changing the potting material used at the ends of the case to a material which has better adhesion characteristics. Also, the cell chimneys will be manifolded together and to the case vent-valve with plastic tubing.

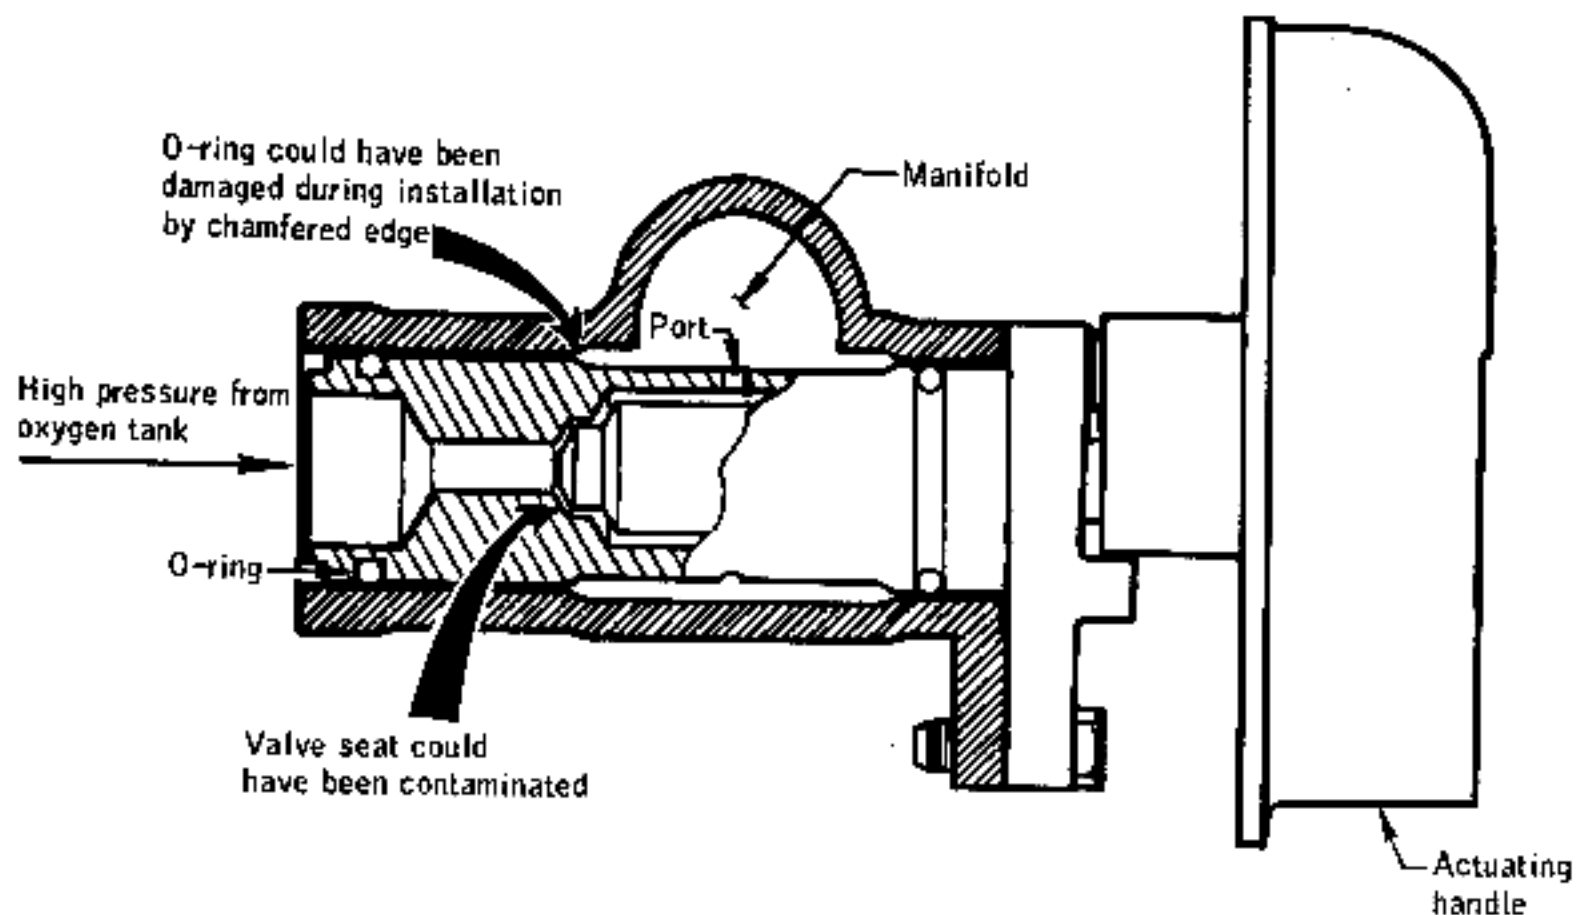
(fig. 14-20) caused the leakage. When the valve is installed, the forward O-ring can be rolled and damaged when it passes the manifold port. In the other two valves, the cause was not identified and was assumed to be contamination.

Figure 14-20.- Ascent stage tank shutoff valve.

compression allowed in the valve design would aggravate the tendency for the O-ring to roll during valve assembly.

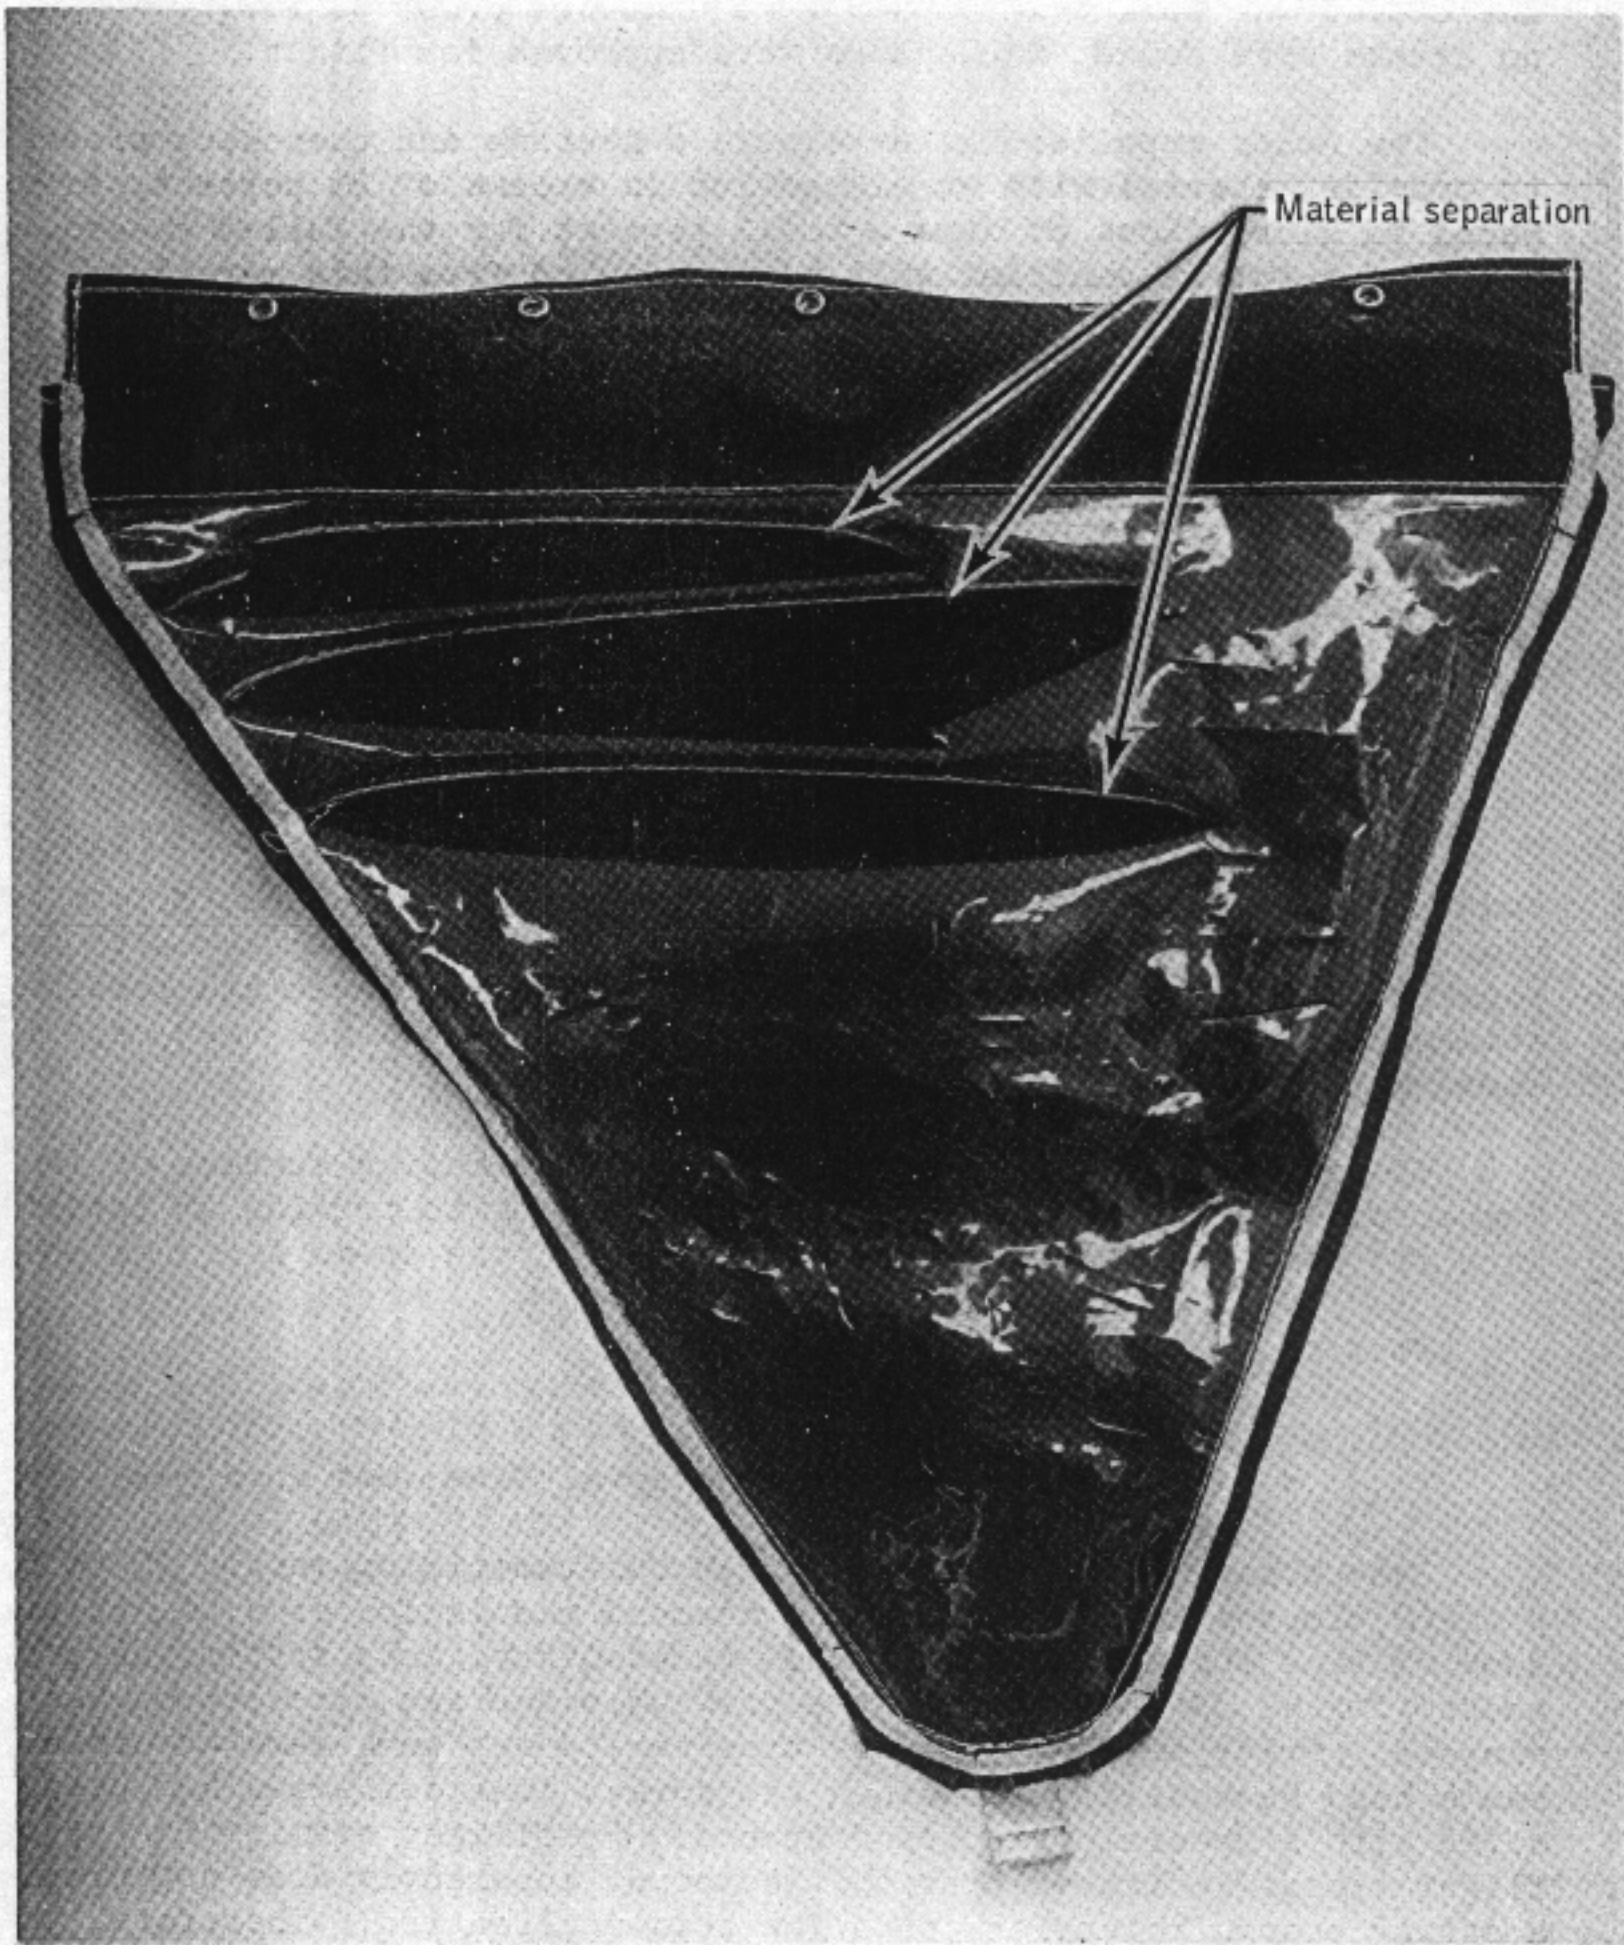
Figure 14-21.- Cracked left-hand window shade.

Cracking as a result of Aclar embrittlement has occurred before, therefore, the Apollo 13 shades were examined prior to flight. Since no cracks were found, the shades were approved for flight.
