[REDACTED]  
[REDACTED]  
756TH AIRCRAFT CONTROL AND WARNING SQUADRON  
Finland, Minnesota  
[REDACTED]

SUBJECT: Radar Observation Data Sheet

I. Description of Incident

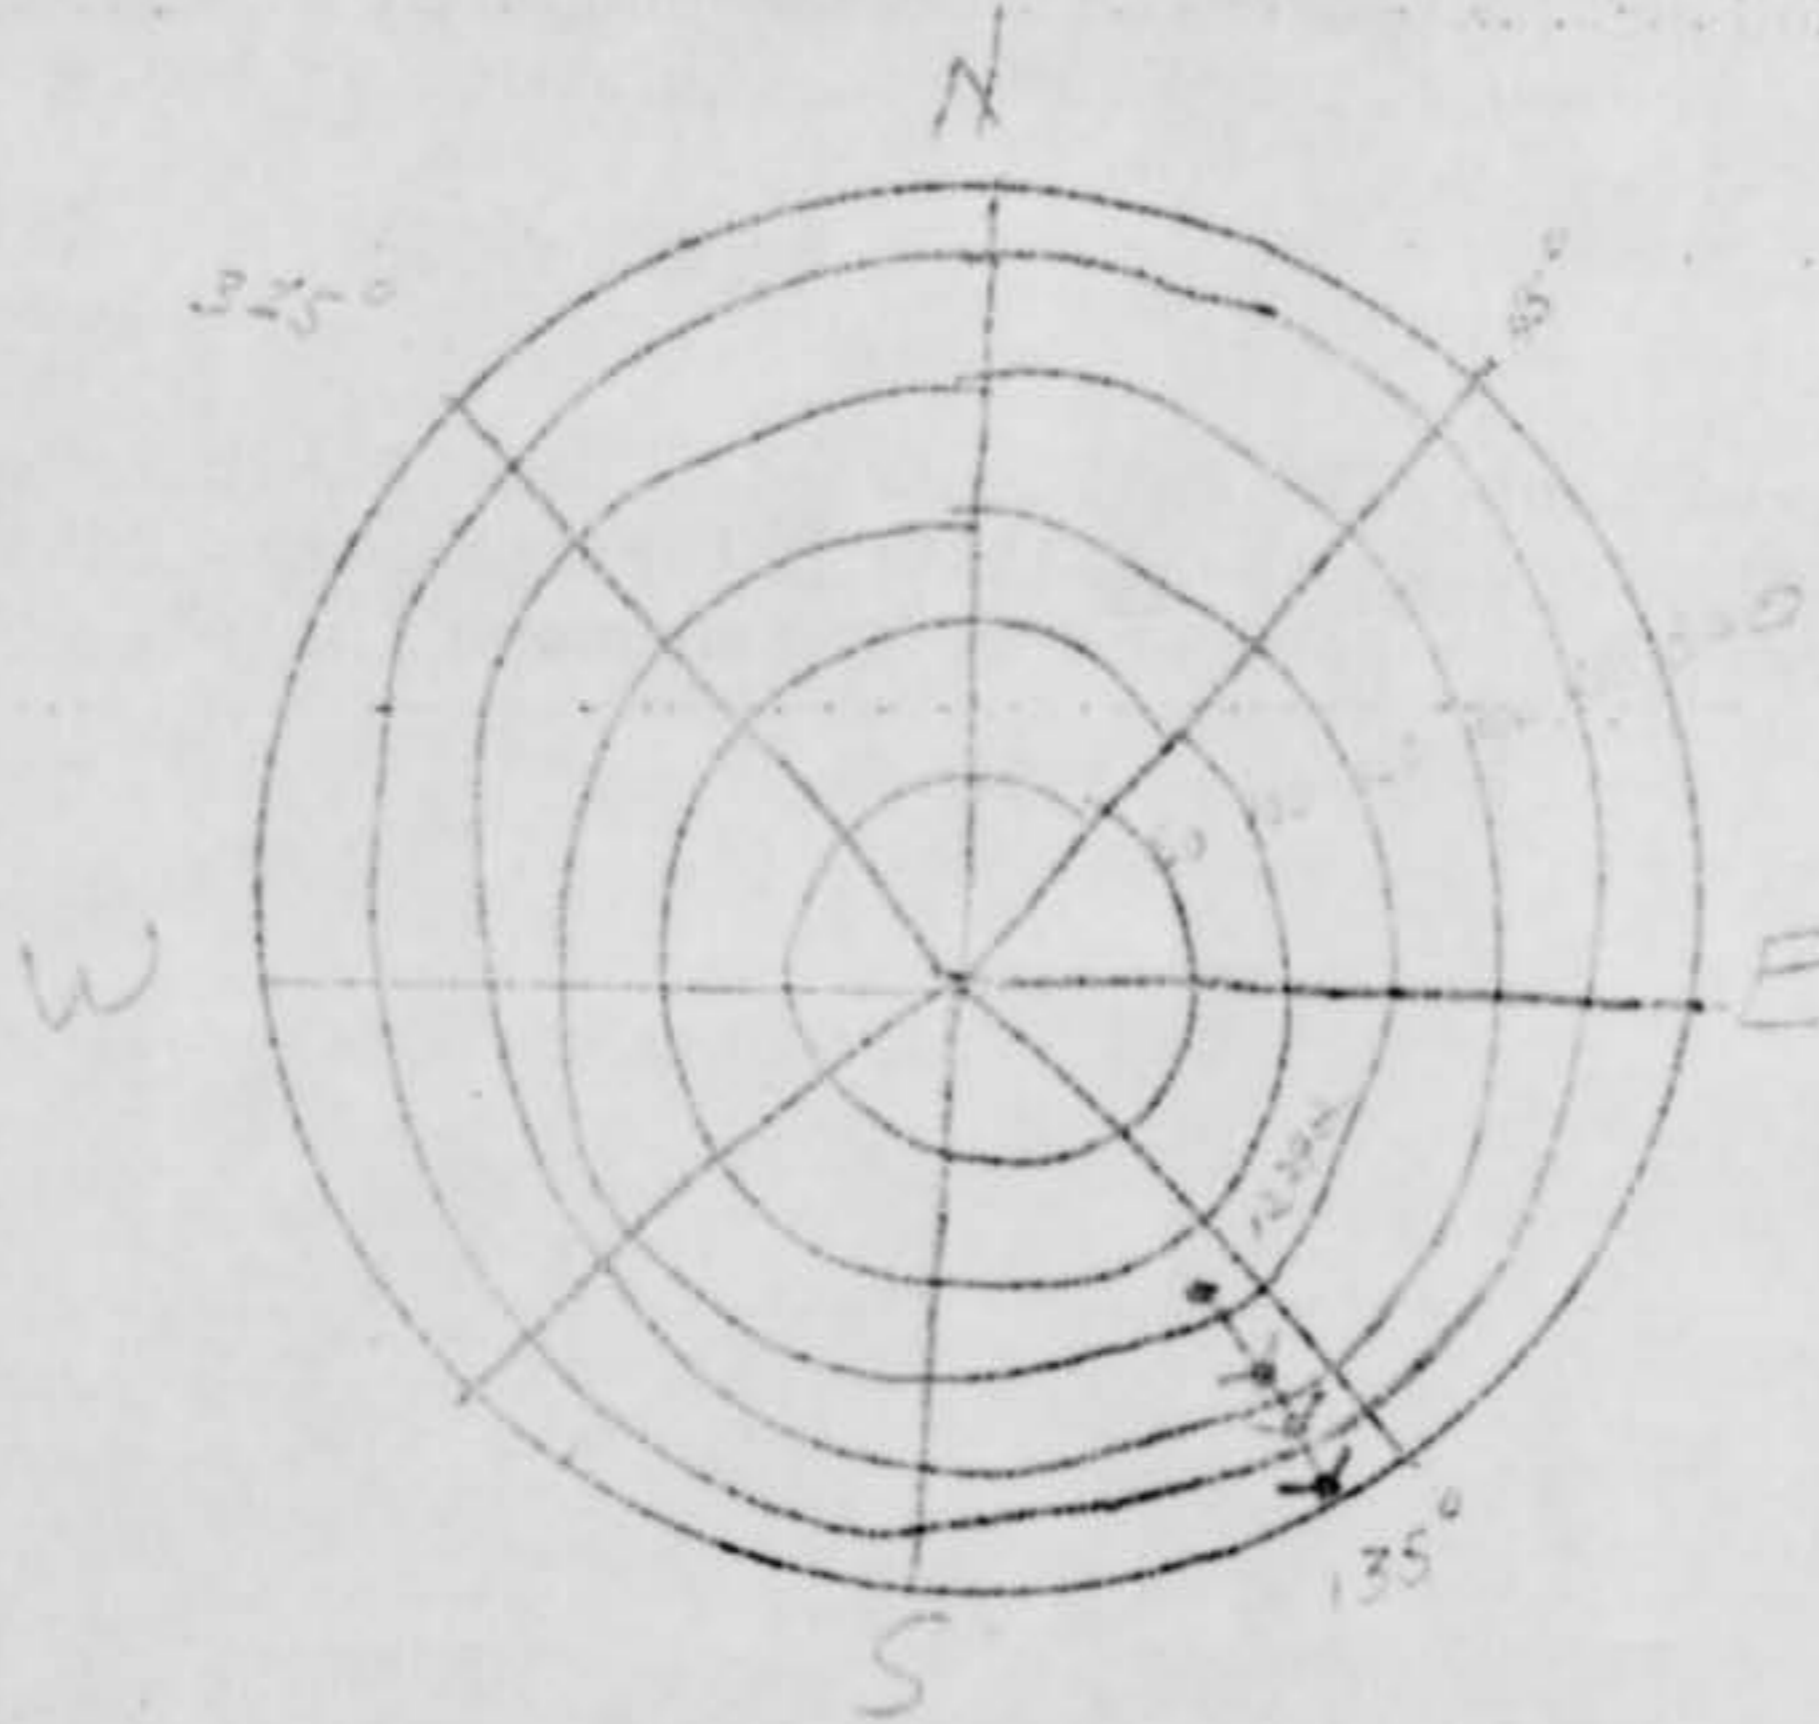
1229Z of INITIAL  
1229Z PLUS 48 SECONDS

RANGE - 140 MILES

AZIMUTH 155 DEGREES

INSTRUCTIONS: PLOT TRACK OF TARGET, INDICATE RANGE AND AZIMUTH. GIVE TIME AT START AND END OF TRACK.
