MSC-02680

APOLLO 13 MISSION REPORT

Mission Evaluation Team

September 1970

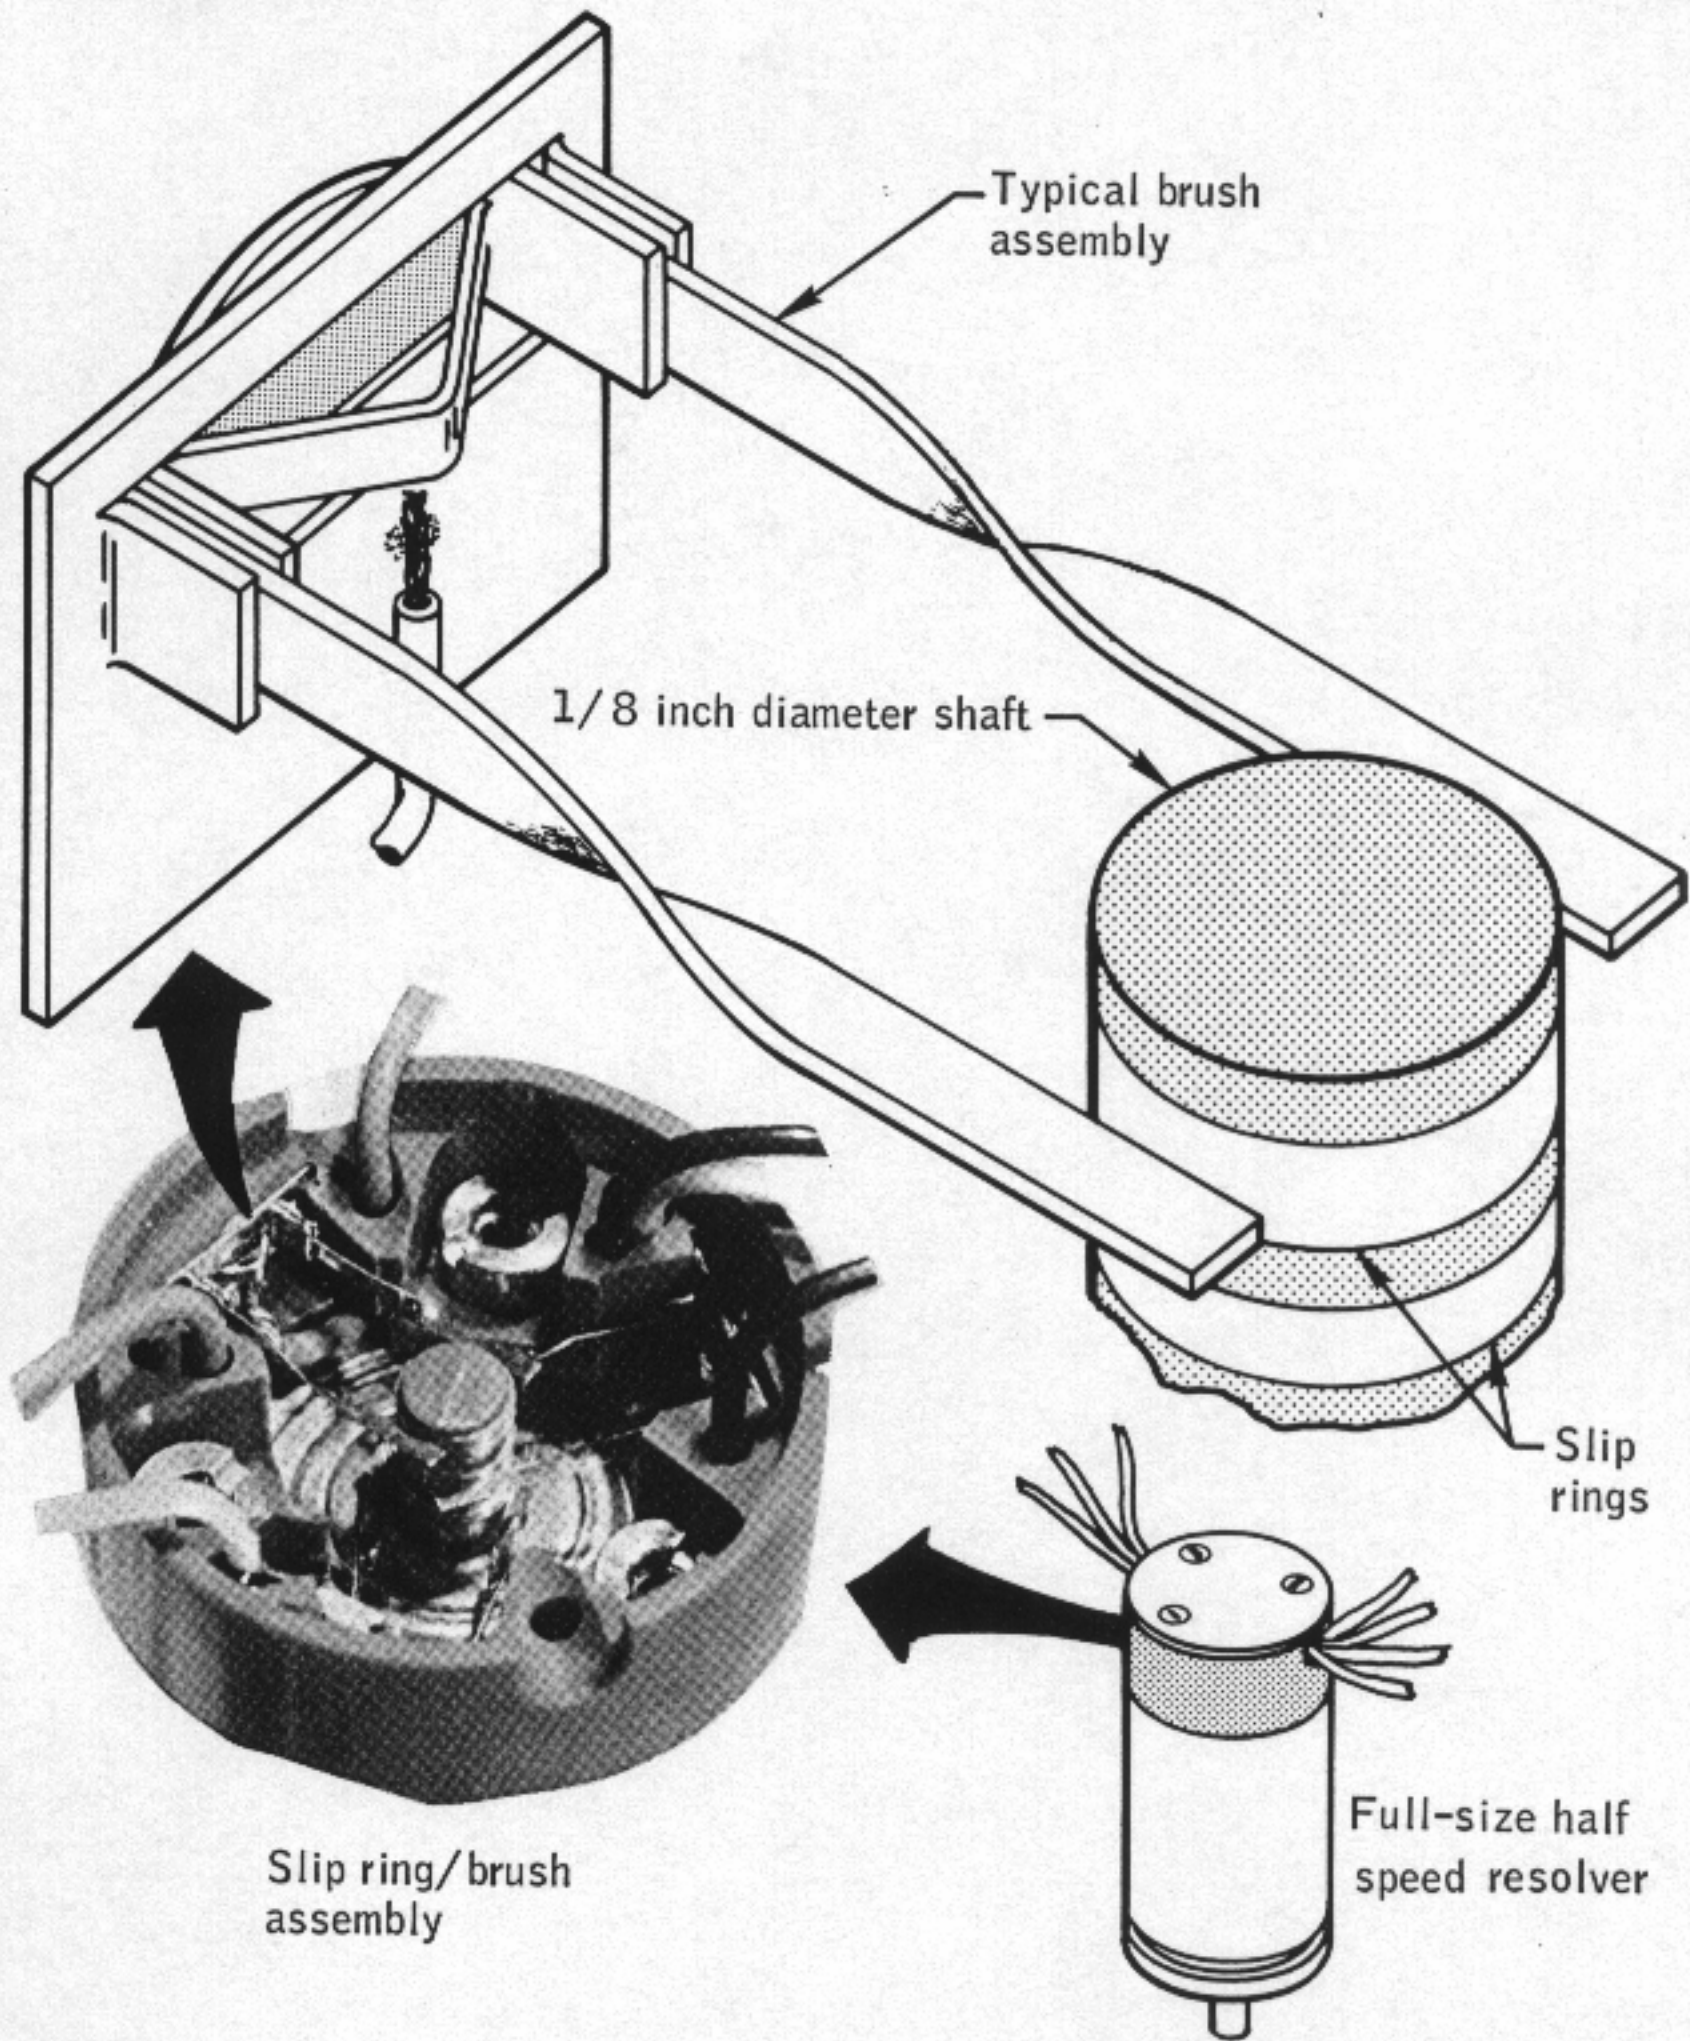
Figure 14-3.- Details of half speed resolver.

The most likely candidate is the half-speed resolver, which is used only for the shaft axis and only to provide an unambiguous zero reference. The reference voltage is applied to the rotor through slip rings (fig. 14-3), connected as shown in figure 14-4. If any resistance is present in the common ground path through the slip ring, a portion of the reference voltage will appear across the quadrature winding and induce a finite output (different than zero). Zero output is equivalent to zero degrees in shaft rotation.

Some evidence of susceptibility to vacuum was exhibited in this class of resolvers during qualification testing when variations of approximately 5 ohms were observed in the slip ring resistance during thermal

vacuum testing. The tests were run with the units rotating at 1 rpm, however, and the momentary resistance changes disappeared with the wiping action.

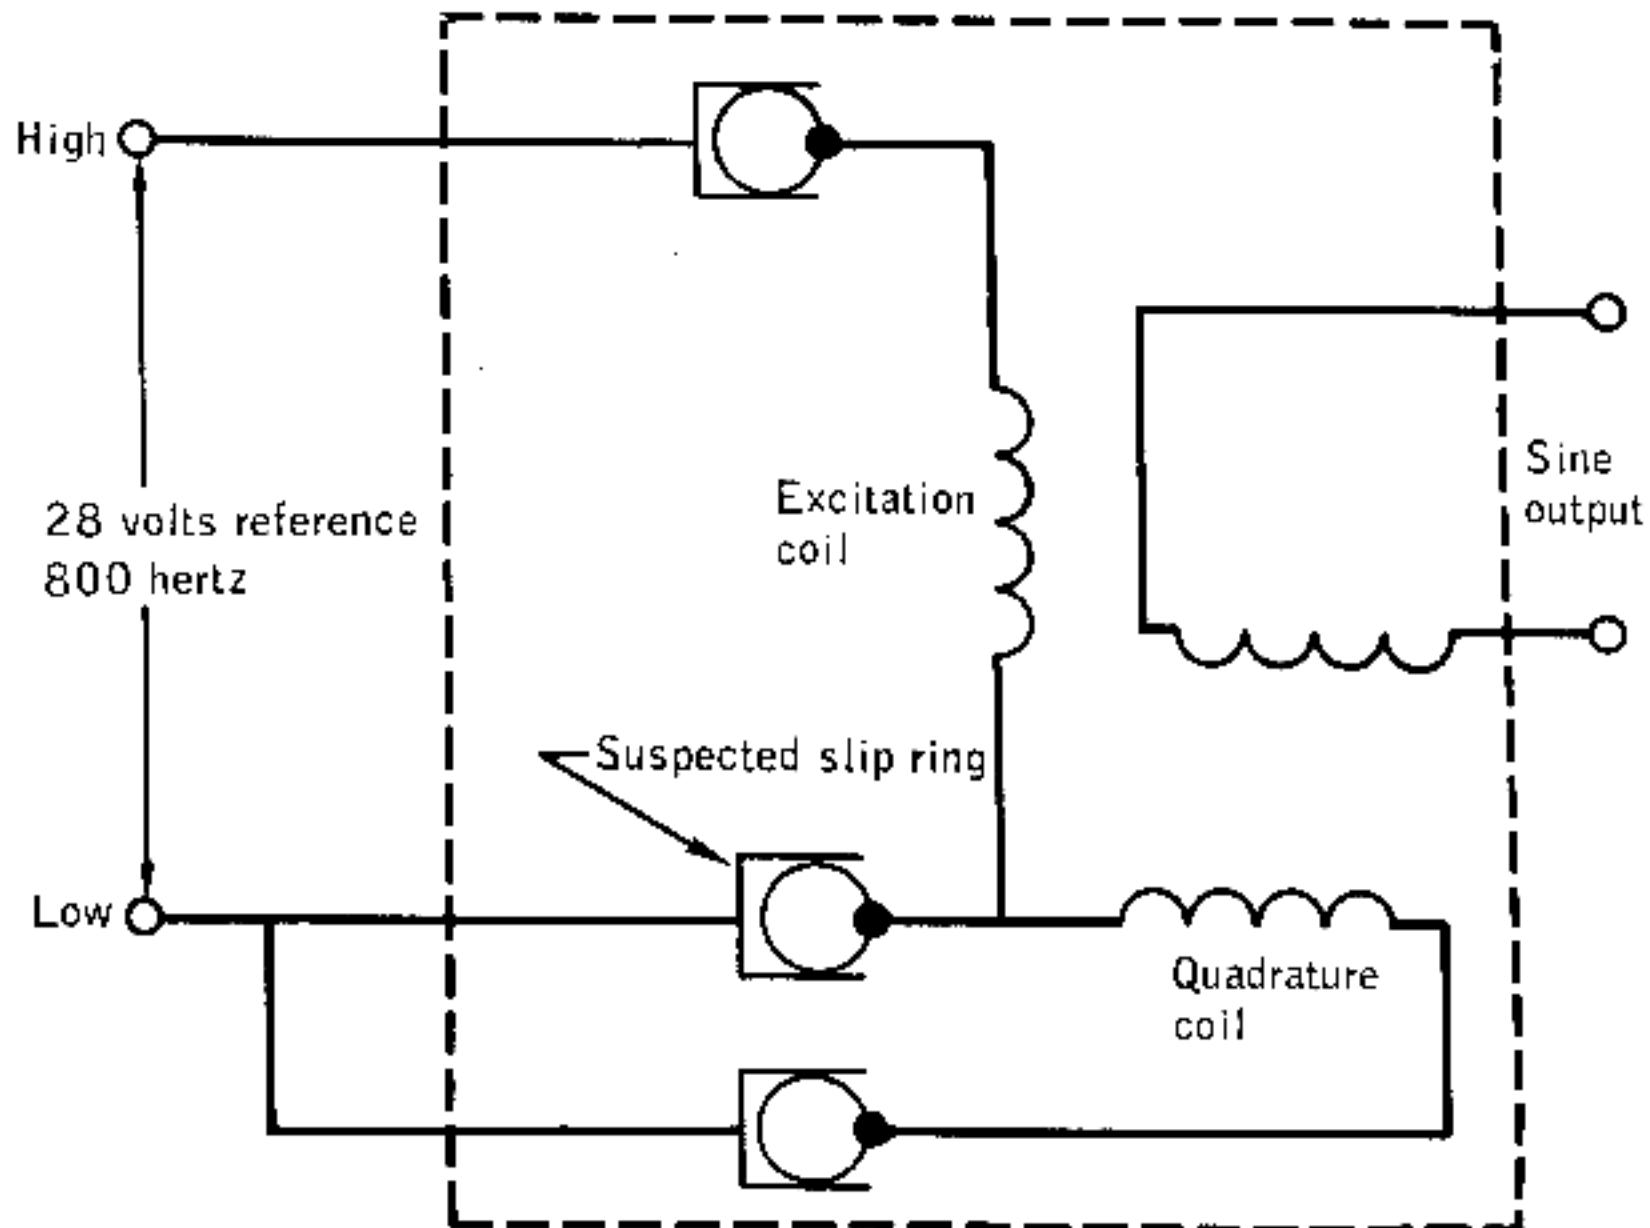
Figure 14-4.- One-half speed resolver.

Simulated changes in slip ring impedance were made on the half-speed resolver in the shaft loop (fig. 14-4). An impedance of 50 ohms produced an offset of approximately plus 0.5 degree in sextant shaft angle. The trunnion loop does not use this type of resolver or connection.

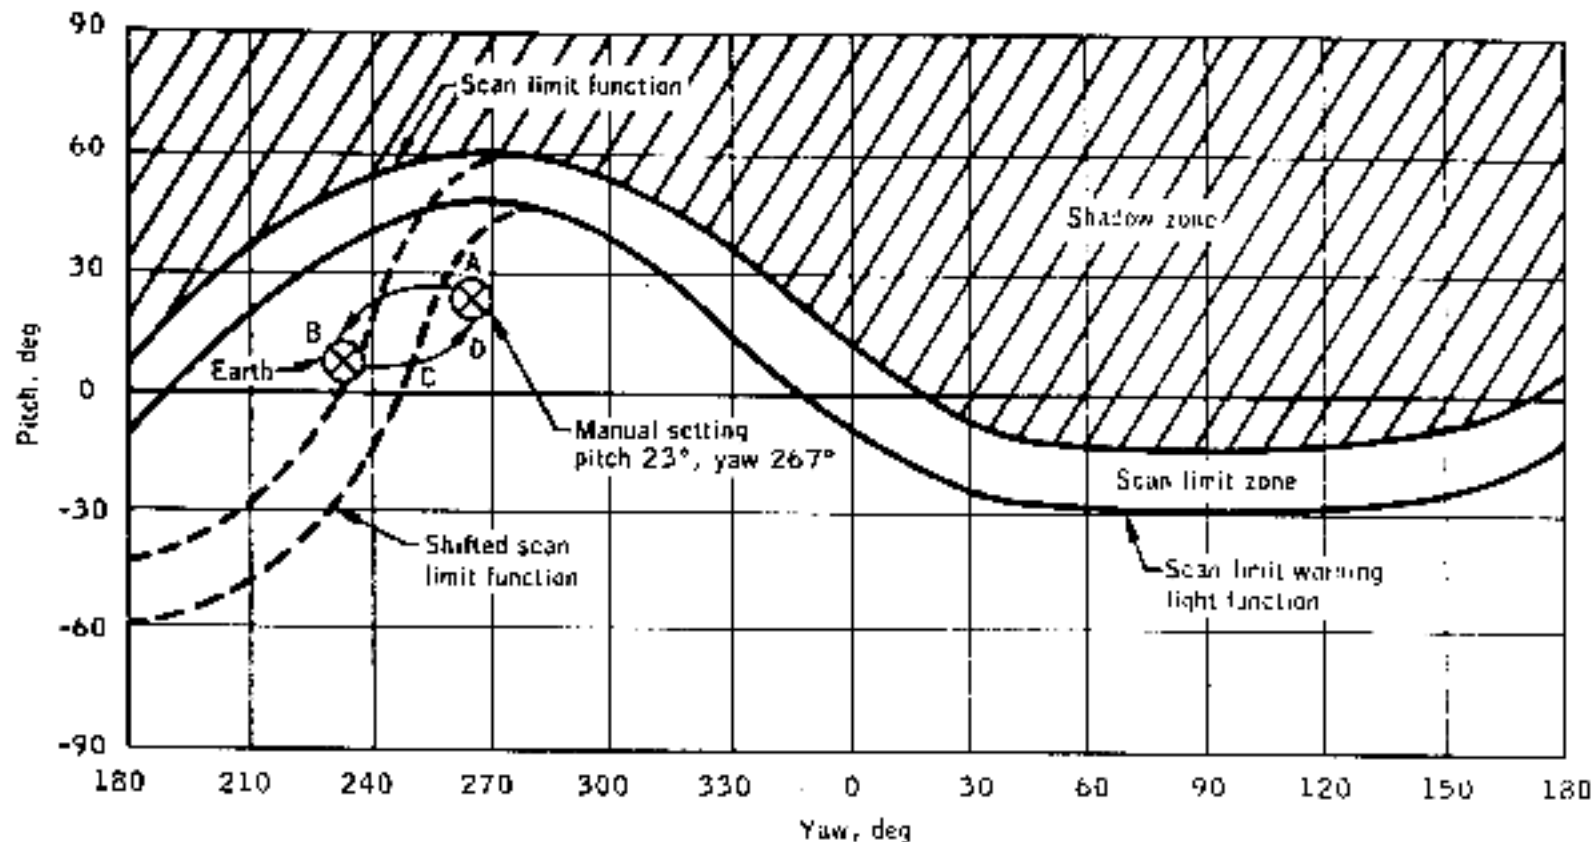
Figure 14-5.- Shift in scan-limit, scan-limit-warning illustrated.

Starting at 55:00:10 and continuing to 55:00:40, deep repetitive transients approximately every 5 seconds were noted on the phase modulated downlink carrier (fig. 14-5). This type of signature can be caused by a malfunction which would shift the scan-limit and scan-limit-warning function lines, as illustrated in figure 14-5. These function lines would have to shift such that they are both positioned between the antenna manual settings and the true line of sight to earth. Also, the antenna would have to be operating in the auto-reacquisition mode to provide these signatures. The antenna functions which caused the cyclic inflight RF signatures resulting from a shift in the function lines can be explained with the aid of figures 14-5 and 14-6, with the letters A, B, C, and D corresponding to events during the cycle. Starting at approximately 55:00:10, the antenna was switched from manual to auto reacquisition with the beamwidth switch in the medium-beam position. From point A to the scan limit function line just prior to point B, the antenna acquired the earth in wide beam. When the antenna reached the scan limit function line, the antenna control logic would switch the system to the manual

mode and drive back toward the manual settings until the scan limit warning function line at point C was reached, thereby maintaining wide-beam operation. When the antenna reaches the scan limit warning function line, the system would automatically switch to the medium-beam mode and continue to drive in the manual mode until the manual setting error was nulled out at point A. The antenna would then switch to the auto-track mode and repeat the cycle. The most important feature of this cycle is that the antenna moves at the manual scan rate between points B and D, which is confirmed by the rapid changes in the downlink signal strength.

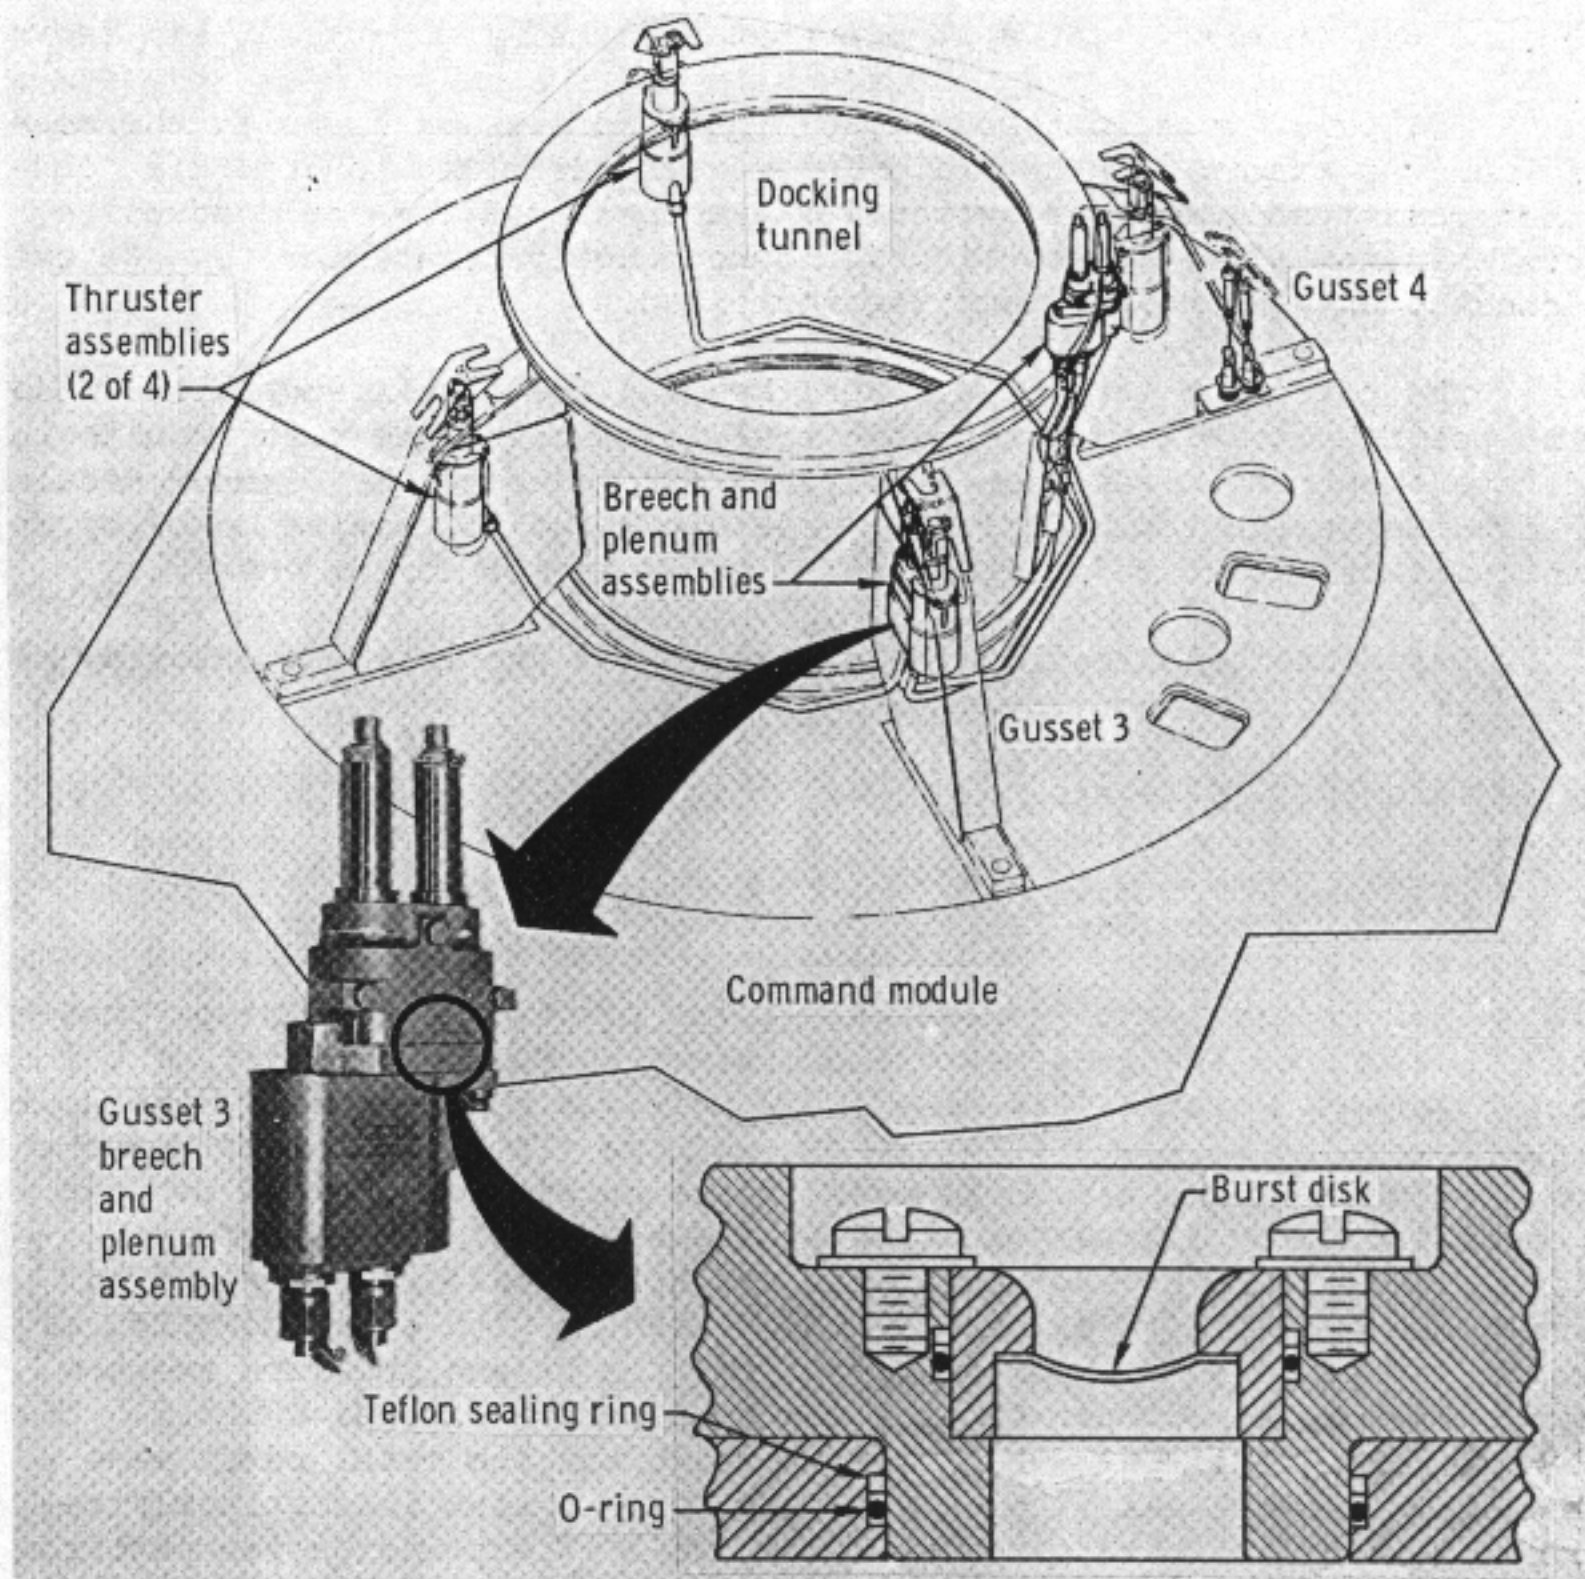
Figure 14-7.- Apex cover jettison system.

During postflight inspection, it was discovered that propellant gas had leaked from the gusset-4 breech assembly, which is a part of the apex cover jettison system (fig. 14-7). A hole was burned through the aluminum gusset cover plate (fig. 14-8), and the fiberglass pilot parachute mortar cover on the parachute side of the gusset was charred but not penetrated. The leakage occurred at the breech-plenum interface (fig. 14-9). The breech and plenum are bolted male and female parts which are sealed with a large O-ring backed up with a Teflon ring, as shown in figure 14-7. During operation, the breech pressure reaches approximately 14 000 psi and the gas temperature exceeds 2000° F. The O-ring and backup ring were burned through and the metal parts were eroded by the hot gas at the leak path. The system is completely redundant in that either thruster system will effect apex cover jettison. No evidence of gas leakage existed on the previous firings of 56 units.

- a. Out of tolerance parts - Measurement of the failed parts indicate acceptable dimensions of the metal parts.
- b. Damaged O-rings - The 21 000-psi static proof-pressure test was successful.
- c. Gap in backup ring - The installation procedure specifies the backup ring may be trimmed on assembly to meet installation requirements,

but does not specify any dimensional control over the scarf joint. Since the gap portion was burned away, a gap in the backup ring could have caused the problem.

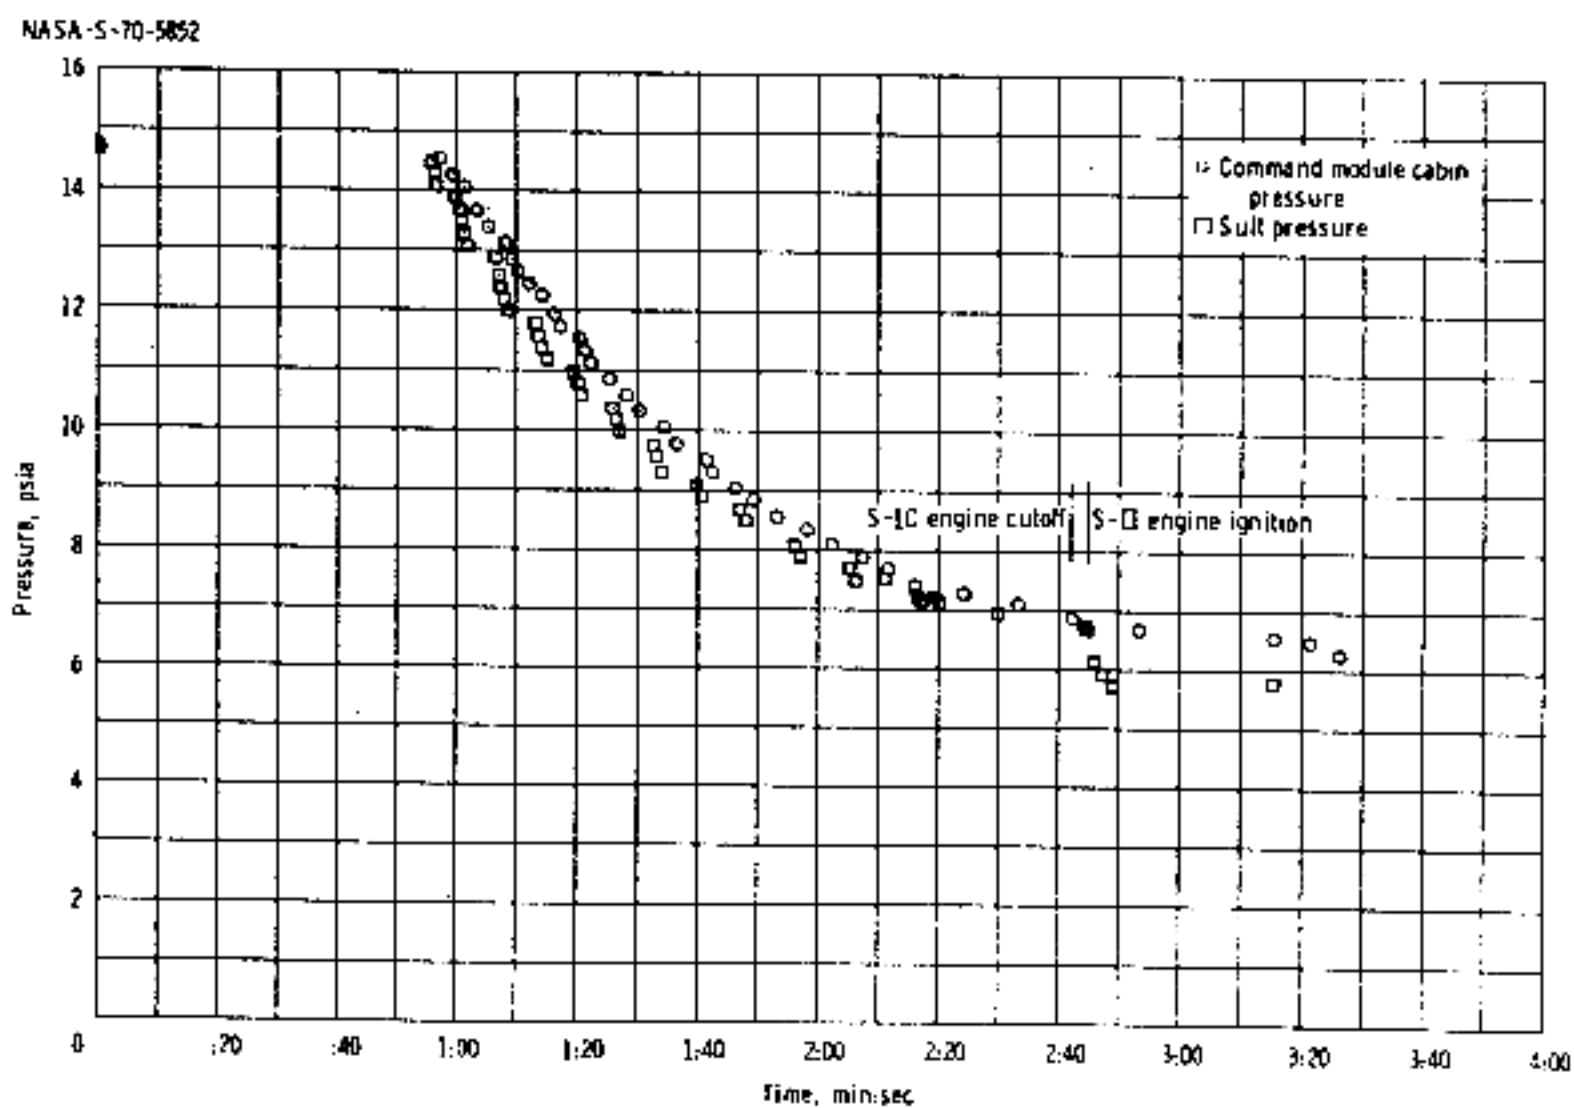
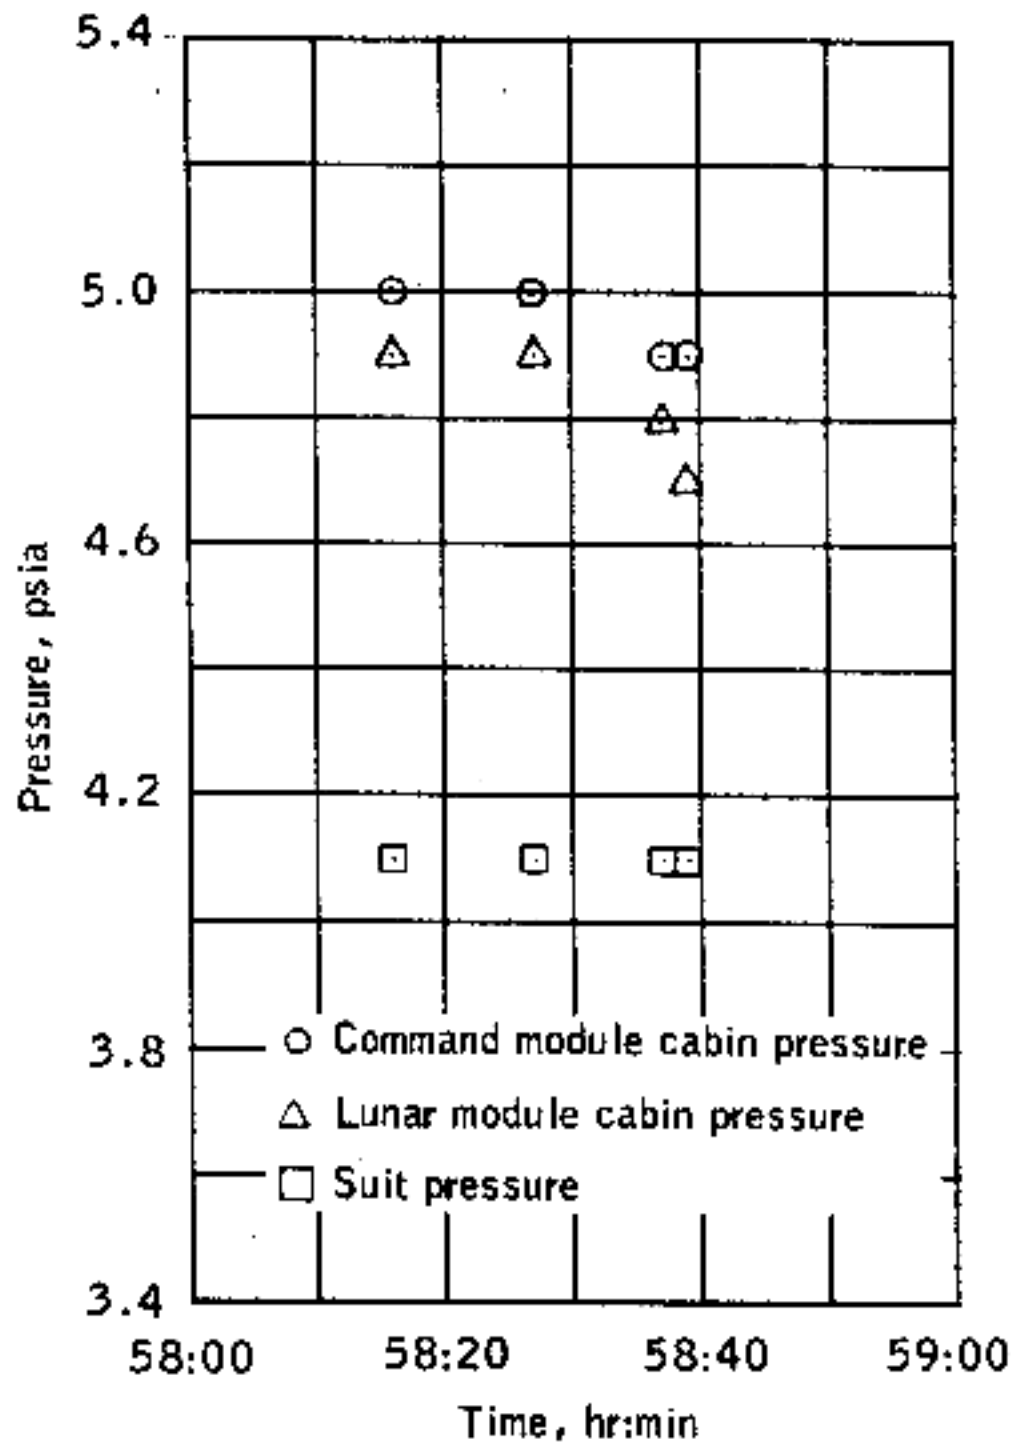
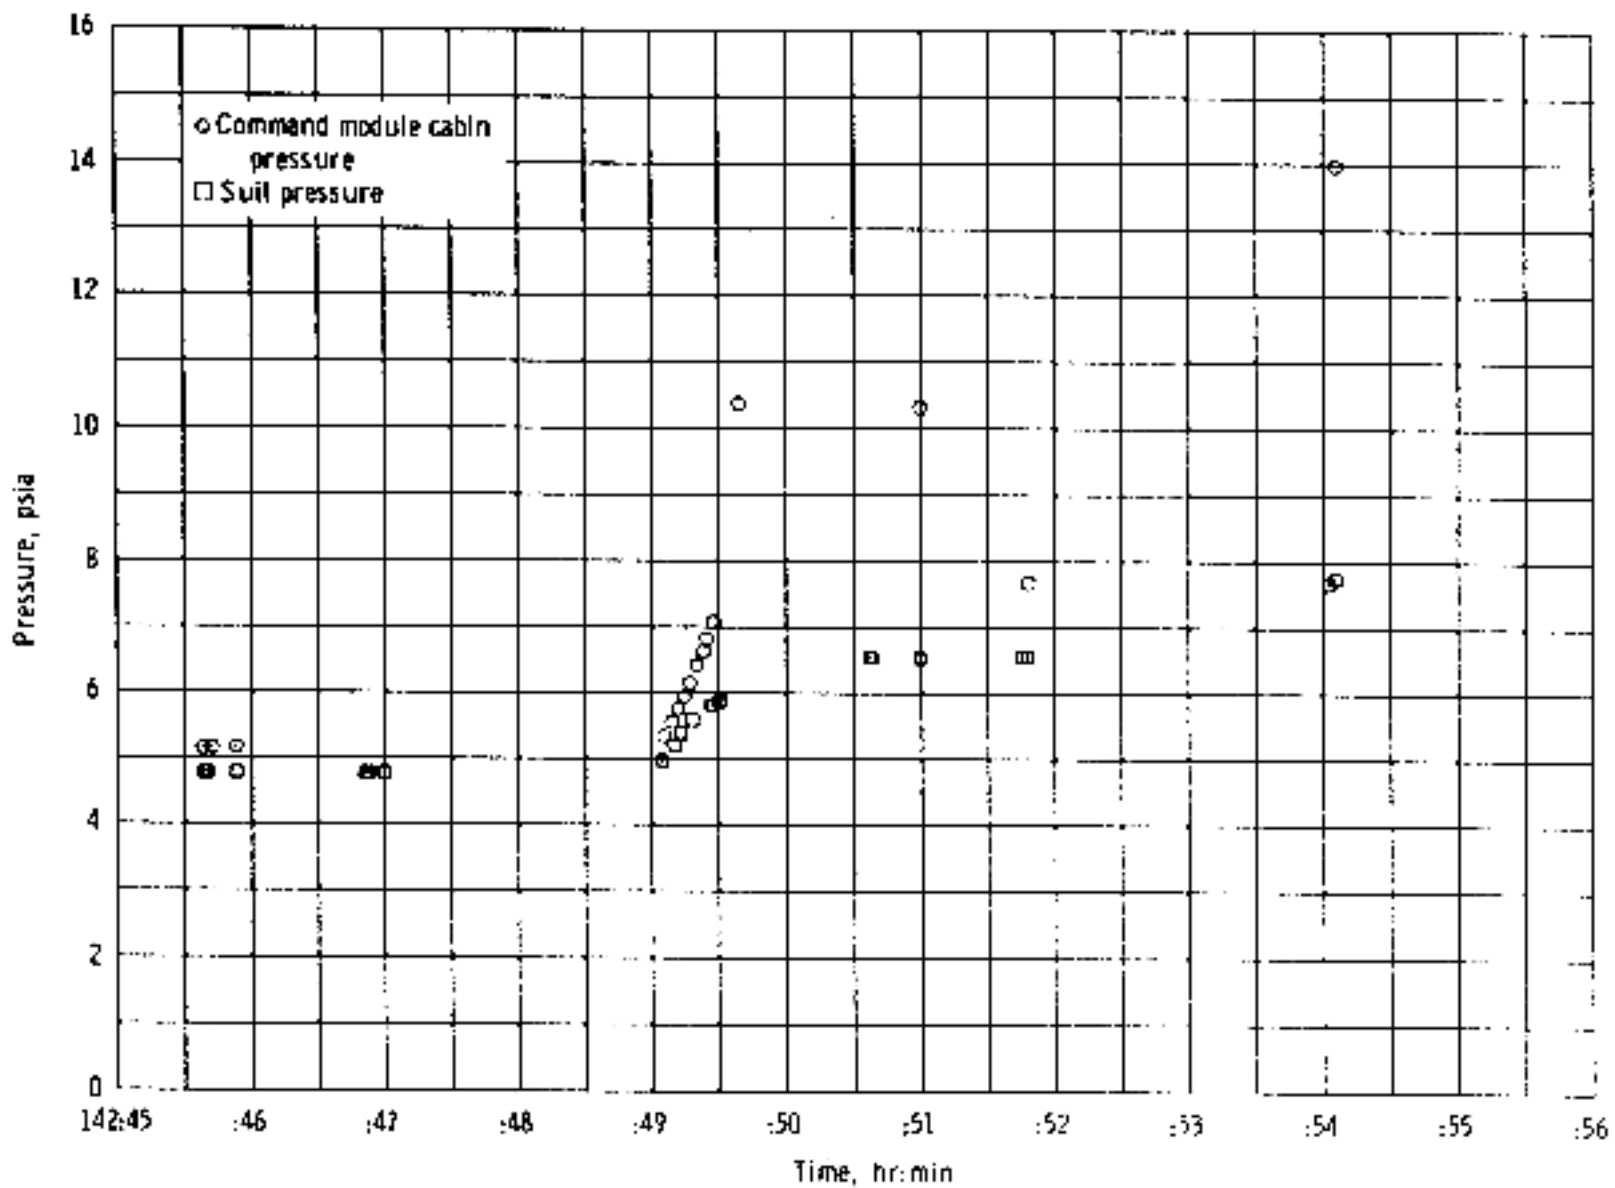
Figure 14-12.- Suit and cabin pressure.

During launch the suit pressure transducer reading remained consistent with cabin pressure until 00:02:45, then suddenly dropped from 6.7 to 5.7 psia coincidentally with S-II engine ignition (fig. 14-12). The difference between the two measurements decreased to only 0.2 by 1-1/2 hours, when the cabin reached its nominal regulated pressure of 5.0 psia. For this shirtsleeve mode, the suit and cabin pressure readings should be nearly equal. During normal variations in the command module cabin pressure, the suit pressure measurement responded sluggishly and indicated as much as 1 psi low. Subsequently, the measurement output decayed and remained in the 4.1 to 4.3 psia range for a cabin pressure of 5.0 psia until system deactivation at about 59 hours (fig. 14-12).

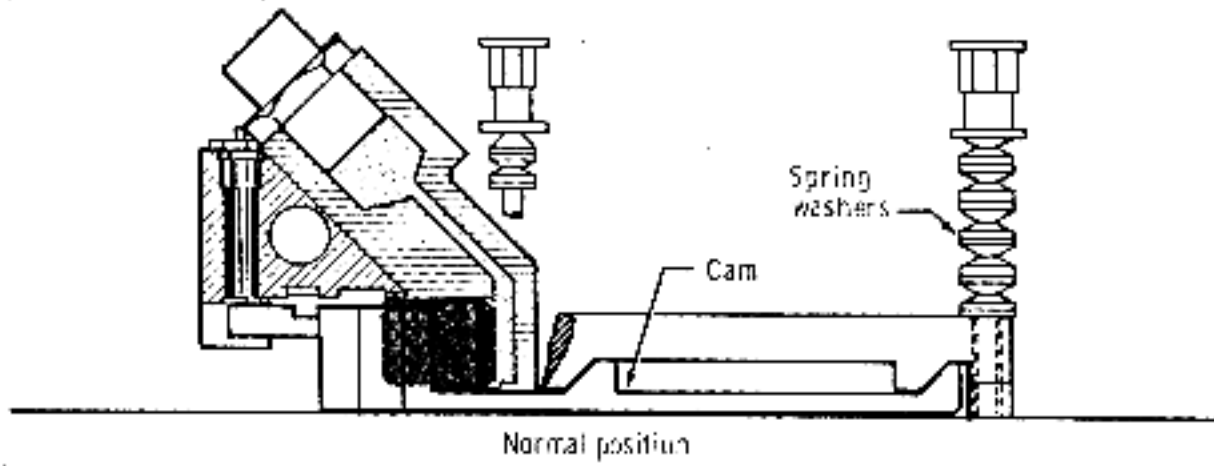
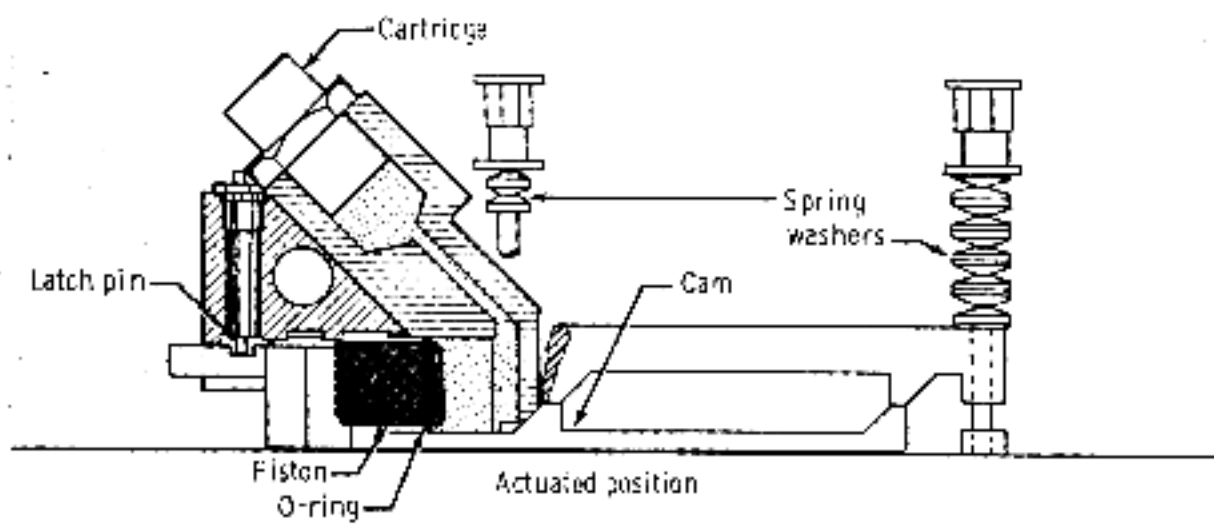
Figure 14-13.- Circuit interrupter.

During postflight inspection of the command module, propellant gas was noted to have escaped from the left-hand electrical circuit interrupter, mounted in the lower equipment bay, and deposited soot on adjacent equipment. The right-hand circuit interrupter showed no evidence of a gas leakage. The removed breech, showing the displaced O-ring and crushed attenuator block, is shown in figure 14-13.

The two interrupters open the electrical circuits about 30 milliseconds before the wires are severed by the command module/service module umbilical guillotine. As illustrated in the figure, a cam fork is moved by a piston, which is operated by propellant gas from redundant cartridges, to function a lift plate. Motion of this plate disconnects the male and female portions of electrical connectors located, respectively, in the lift plate and in the base plate of the interrupter. At the completion of the stroke, the fork is brought to rest by impacting and crushing an aluminum block mounted on the interrupter housing.

The worse-case tolerance buildup is when the fork contacts the attenuator block and the piston O-ring is 0.075 inch from entering the chamfer in the breech assembly. The O-ring enters this chamfer when the block has been crushed about 94 percent, at which point an O-ring displacement and accompanying gas escape could be expected. The factors which affect the degree of attenuator crushing are generally uncontrollable within narrow limits and include:

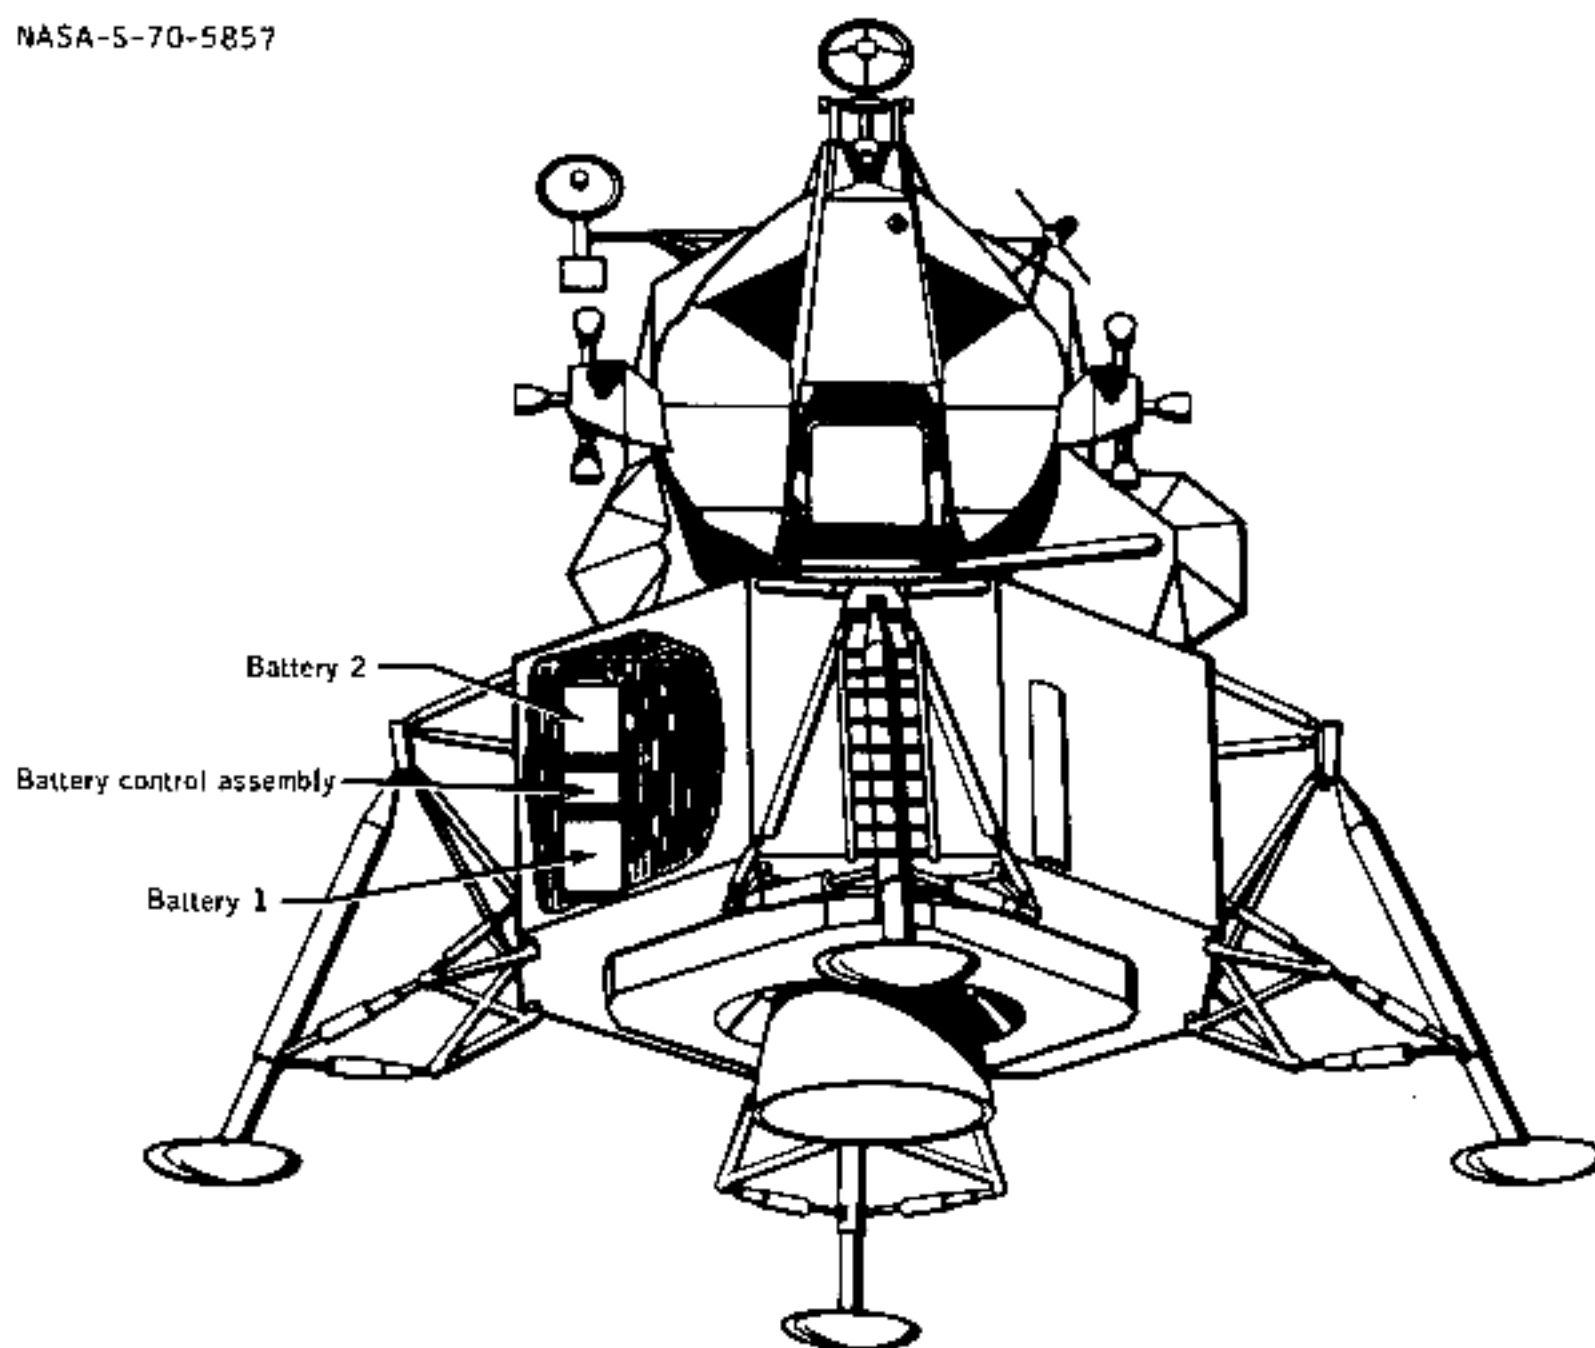
Figure 14-15.- Descent stage battery location.

At 97 hours 14 minutes, the crew reported a thumping noise and snowflakes venting from quadrant 4 of the lunar module descent stage (fig. 14-15). All four descent batteries experienced current transients at 97:13:53 for about 2 seconds, with corresponding drops in dc bus voltage (fig. 14-16). Also, the water glycol pressure differential for the heat transport system decreased momentarily, indicating that the glycol pump momentarily slowed down.

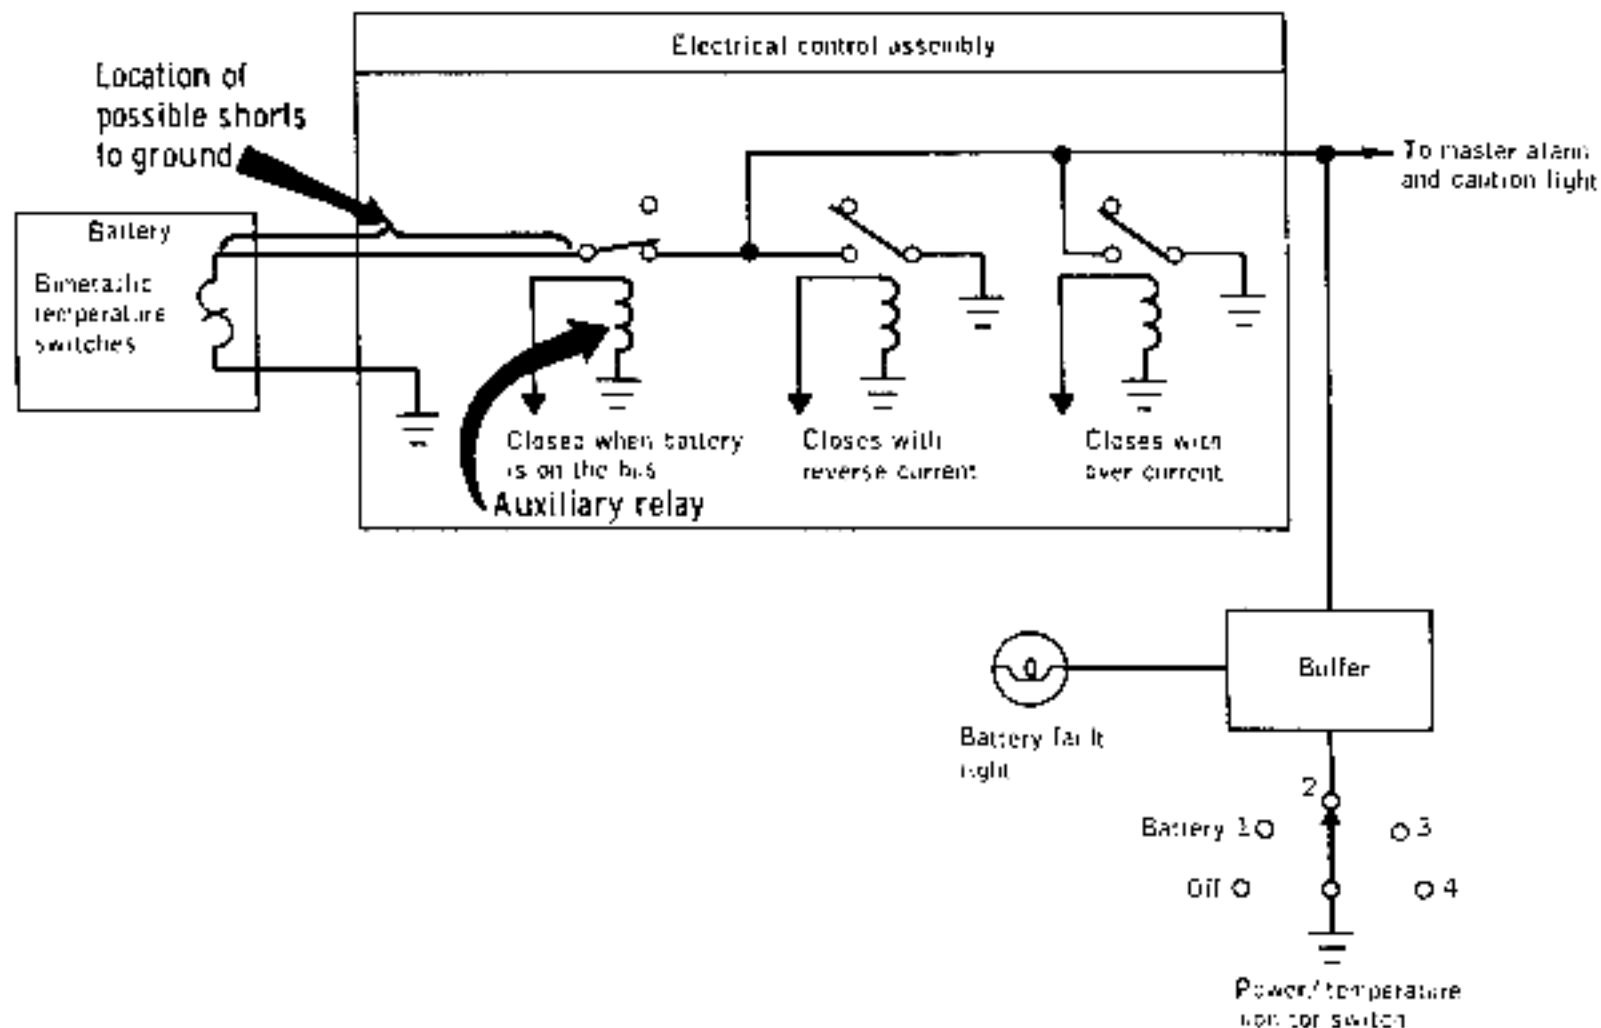
Figure 14-18.- Battery 2 malfunction circuit.

The battery malfunction light illuminated at about 100 hours with a corresponding master alarm. The malfunction, isolated to battery 2, could have been caused by an overcurrent, a reverse-current condition, an over-temperature condition, or possibly an erroneous indication. The logic for these malfunction conditions is shown in figure 14-18.

A battery overcurrent can be ruled out because automatic removal of the battery from the bus would have occurred.

A reverse-current condition can be ruled out because, if the battery is removed from and reapplied to the bus, the reverse-current circuit has a built-in delay of about 5 seconds before the reverse-current relay is again activated to illuminate the light. Battery power was removed from and replaced on the bus in flight, and the light immediately illuminated again when the battery was reconnected.

An over-temperature condition can be ruled out because, after the battery was replaced on the bus, the light remained illuminated for a brief period and then began flickering intermittently. A flickering light cannot be caused by the temperature sensing switch because of a temperature hysteresis of approximately 20° F in the switch. The water glycol loop temperature also indicated that the battery temperature was normal.

Either a short between the temperature switch wires to ground or a contamination in the auxiliary relay would actuate the light. The shorted condition could have resulted from electrolyte shorting within the battery case associated with the current surges discussed in the previous section. Contamination of the auxiliary relay has occurred in the past, and relays already packaged were not retrofitted since a false over-temperature indication can be identified as it was here.
