MSC-02680

APOLLO 13 MISSION REPORT

Mission Evaluation Team

September 1970

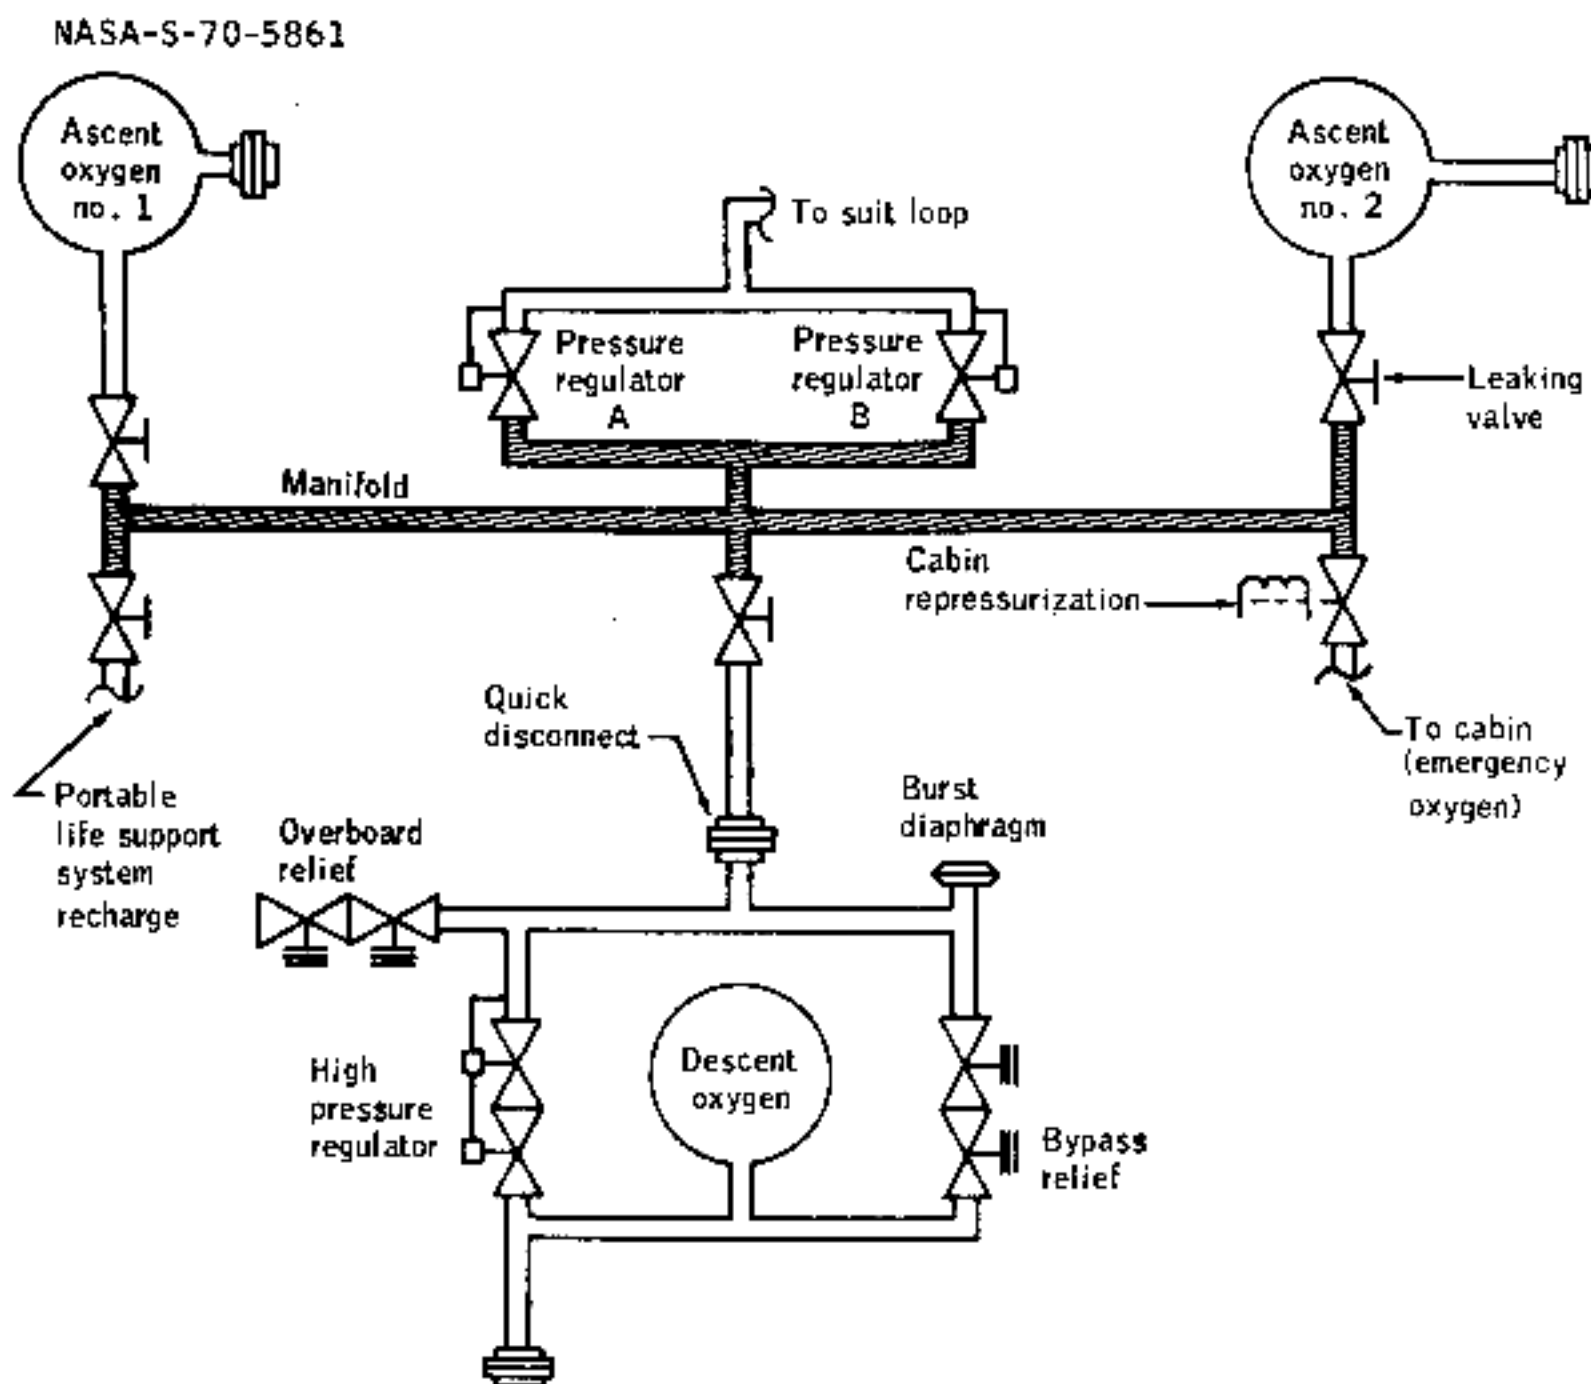
Figure 14-19.- Oxygen-supply system.

During the flight, the pressure in the ascent stage oxygen tank 2 increased, indicating a reverse leakage through the shutoff valve from the oxygen manifold (fig. 14-19) into the tank. The leak rate, with a maximum differential pressure of 193 psi, varied from about 0.22 lb/hr (70 000 scc/hr) to zero when the tank pressure reached manifold pressure. Allowable leakage for the valve in either direction is 360 scc/hr. Pre-flight test data indicate a reverse leakage of 360 scc/hr and no excessive leaking in the forward direction.

The internal portion of three valves of this type had been replaced previously on the spacecraft because of excessive leakage through the ascent oxygen tank 1 shutoff valve. In one valve, a rolled O-ring

(fig. 14-20) caused the leakage. When the valve is installed, the forward O-ring can be rolled and damaged when it passes the manifold port. In the other two valves, the cause was not identified and was assumed to be contamination.

The production tolerances of the valve and bore were examined to determine if a tolerance buildup problem existed. The manufacturer's specification to which the valve was designed requires that the O-ring be subjected to a compression of between 0.0115 and 0.0225 inch, whereas the O-ring supplier recommends between 0.011 and 0.017 inch. The added

Leak tests previously performed on the valve were inadequate, in that only reverse leakage at high pressure was determined. For future vehicles, forward and reverse leakage at both high and low pressures will be measured to detect any defective valves.
